# Study on collapse mechanism and treatment measures of portal slope of a high-speed railway tunnel

**Abstract.** The slope of an open cut tunnel is located above the exit of the Leijia tunnel on the Changgan high-speed railway. During the excavation of the open cut tunnel foundation pit, the slope slipped twice, a large landslide of 92500 m<sup>3</sup> formed. The landslide body and unstable slope body not only caused the foundation pit of the open cut tunnel to be buried and the anchor piles to be damaged but also directly threatened the operational safety of the later high-speed railway. Therefore, to study the stability change in the slope of the open cut tunnel under heavy rain and excavation conditions, a 3D numerical calculation model of the slope is carried out by Midas GTS software, the deformation mechanism is analyzed, anti-sliding measures are proposed, and the effectiveness of the anti-sliding measures is analyzed according to the field monitoring results. The results show that when rainfall occurs, rainwater collects in the open cut tunnel area, resulting in a transient saturation zone on the slope on the right side of the open cut tunnel, which reduces the shear str

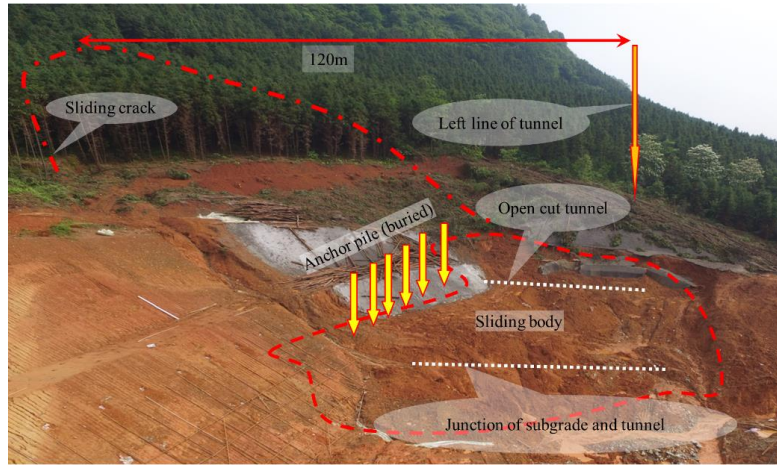
temporary support works of the slope and front slope were carried out, and the anti-sliding pile hole was excavated at the position of the primary platform. In April 2016, heavy rainfall occurred in the area where the tunnel was located, and the originally wet slope began to seep. In particular, the area 5 m above the secondary platform on the right slope of section DK36 + 005 became a water inflow area after rain (Fig. 3(b)). The whole front slope collapsed and fluid gushed out, and a tensile fracture with a width of approximately 80 cm appeared at the rear edge of the landslide. The constructed anti-sliding pile hole on the right side of the open cut tunnel was buried by a landslide (Fig. 3(c)). The landslide mass is tongue shaped on the plane, approximately 120 m in length and 25 m in width; the area of the landslide body is approximately 9100 m<sup>2</sup>(Fig. 3(a)).

(a) Picture of the slope collapse

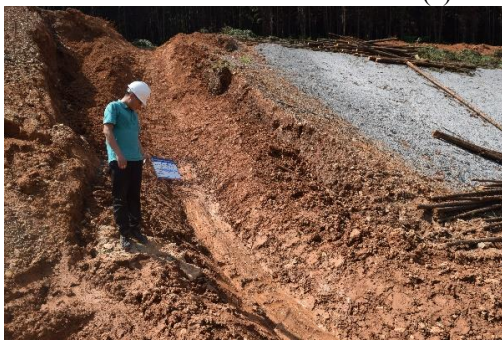
(b) Water inflow area

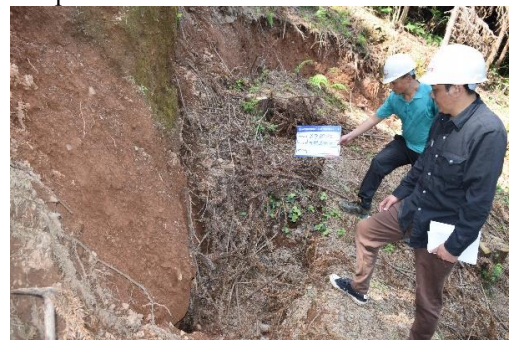
(c) Tensile cracks at the trailing edge of the slope

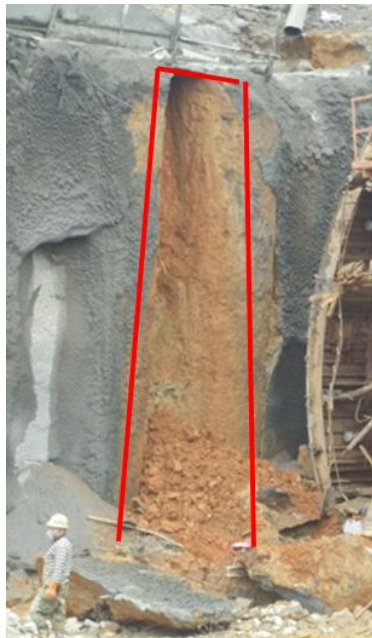
(a) Collapse of the soil between piles

the soil collapsed between the bored cast-in-place piles on the right side of the exit open cut tunnel (Fig. 4(a)). Then, large cracks on the slope (Fig. 4(b)) and obvious displacement of the bored cast-in-place pile on the right side of the open cut tunnel were found (Fig. 4(c)).

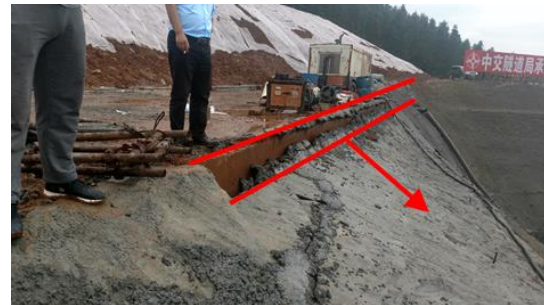
(b) Slope cracking

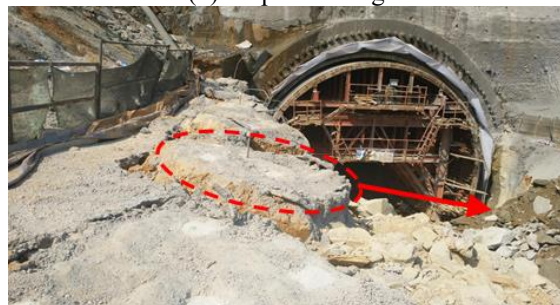
(c) Lateral displacement of pile top

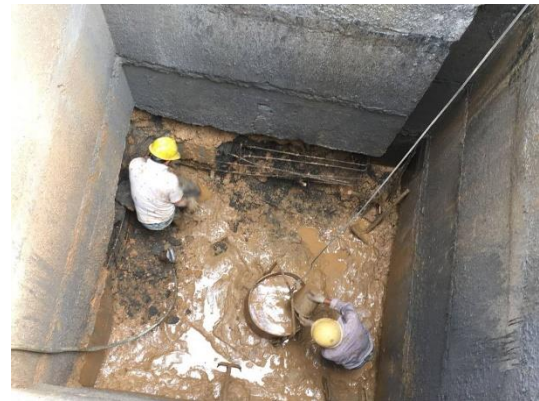
(b) Excavation of anchor piles

In the first stage, the soil mass of the slope above the top of the anchor pile was excavated, and several anchor piles were excavated, as shown in Fig. 9(b). During this period, no effective protection or drainage measures were formed on the slope surface, and the excavation of large-scale anchor piles further damaged the anti-sliding capacity of the slope toe. At the same time, slope excavation destroyed the vegetation, increased the infiltration of rainwater, and accelerated the formation of a soft layer in the soil, resulting in a collapse of the slope in April 2016, as shown in Fig. 3. The second stage of excavation was executed after some reinforcement measures were completed, and the excavated area was mainly the soil of the open cut tunnel. This stage was affected by the accumulation of excavation deformation generated in the previous stage, and the anti-sliding ability of the original anchor pile was insufficient, which led to the stability of the soil in the lower part of the slope again.

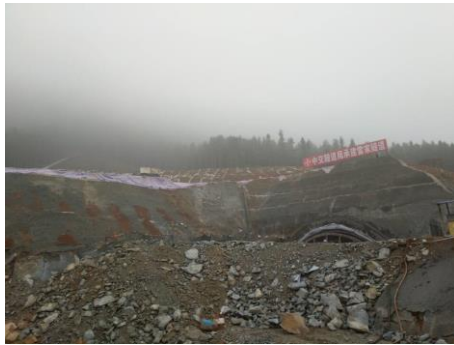
(a) Earth and rock backfill

Back-pressure backfilling is an effective temporary treatment measure that can effectively improve the resistance of the slope toe; therefore, the emplacement of temporary protective measures is also designed from these two aspects. According to the above analysis, excavation and rainfall are the two main sliding-inducing factors, so back-pressure backfilling at the toe of the slope is carried out for the first time that the slope collapses (Fig. 10(a)). At the same time, to prevent rainwater from infiltrating and weakening the soil, multiple intercepting ditches and drainage ditches are excavated at the open line of the slope to ensure that the ground rainwater can be drained in time (Fig. 10(b)), and M7.5 mortar is used to block the cracks. Furthermore, the damaged shotcrete on the slope surface should be removed, respraying measures should be carried out; the inclined drainage holes on the slope should be encrypted at a depth of 10 m, and perforated corrugated pipes or PVC pipes should be inserted into the drainage holes.

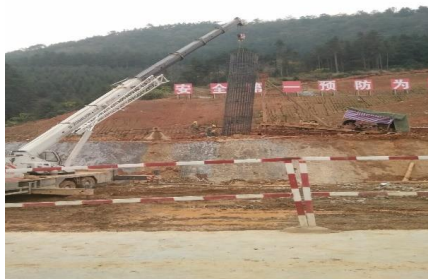
(c) Addition of anchor piles

the anchor pile is designed as a circular bored cast-in-place pile with a pile diameter of 2 m, a pile spacing of 3 m, a pile length of 18 m, and a crown beam with a thickness of 1.5 m is set on the top of the pile. The length of the anchor cables is 25 m, the longitudinal spacing is 3 m, the length of the anchor section is 15 m, the inclination angle is 25 degrees, and the prestress is applied at 300 kN, as shown in Fig. 10c.

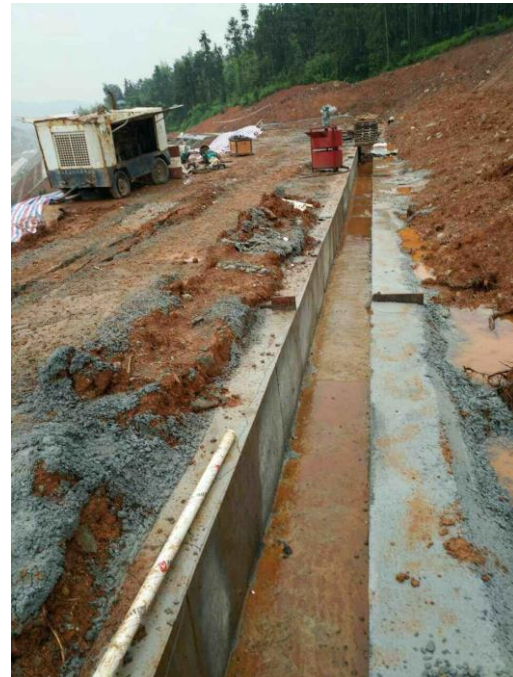
(b) Interception and drainage measures
