Damage identification in a wrought iron railway bridge using the inverse analysis of the static stress response under rail traffic loading

Keywords: damage identification; health monitoring; inverse analysis; railway bridge; static; strain; stress response

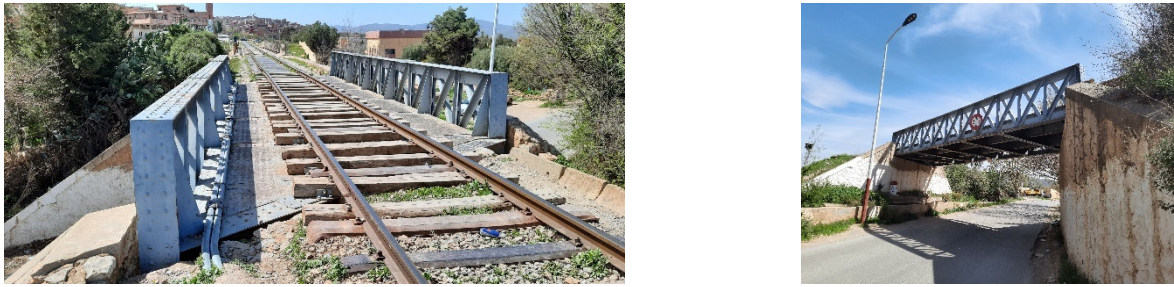
Fig. 1 General view of the bridge of Ouled Mimoun (Tlemcen - Algeria)

iron) bridges. As shown in Fig. 1, the structure in question is a skew metal bridge, located at the entrance to the railway station of Ouled Mimoun. The structure is composed of two main truss girders, measuring 13.6 m in length and 1.50 m in height, and a lower 4.80 m wide deck. This deck is crossed by a single unballasted railway track that is supported by wooden sleepers directly laid on the stringers, as is clearly shown in Figs. 2(a)-(b). The bridge simply rests

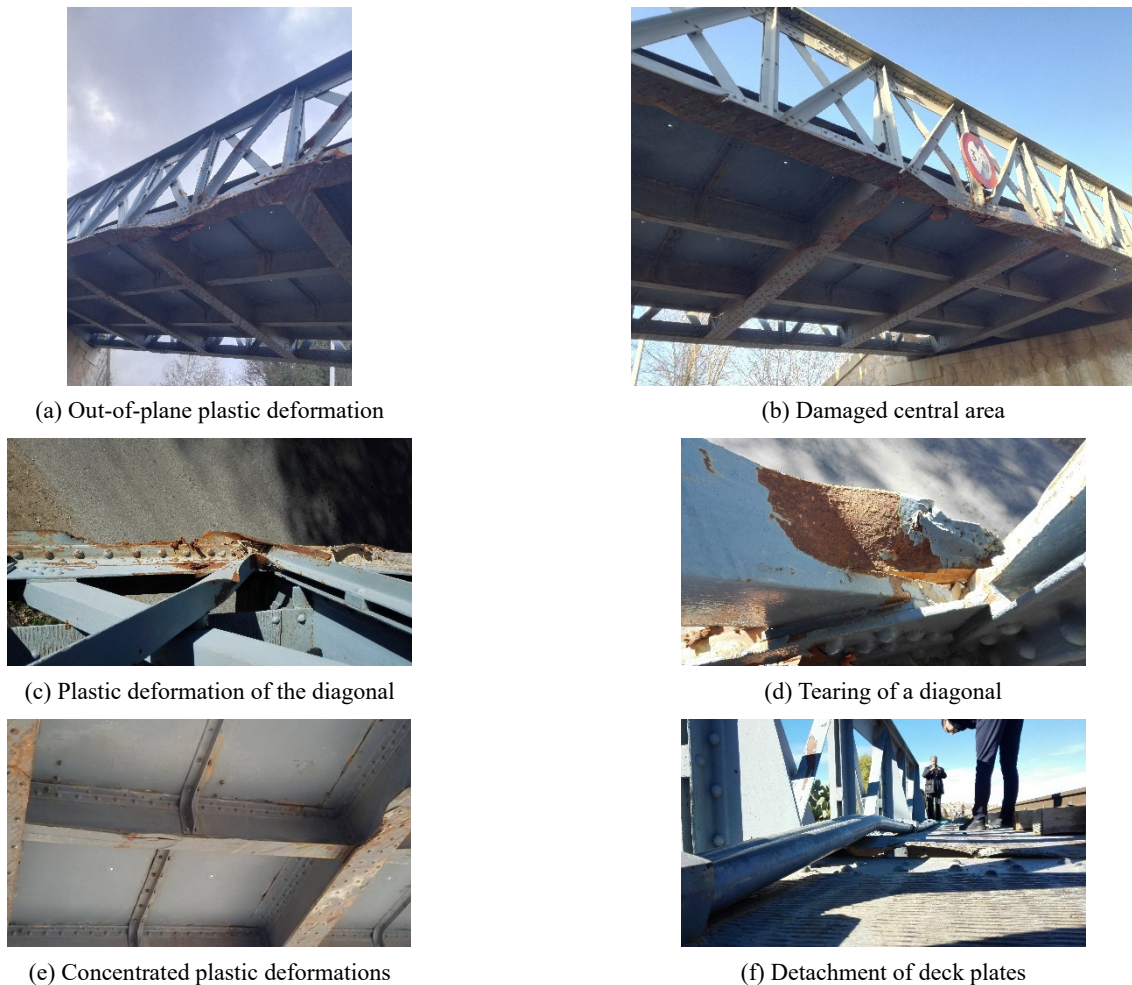
Fig. 3 Pathologies identified on the structure

During its 130 years of service, the bridge has been subjected to several impacts from trucks, particularly during the last few decades, due to its low elevation above the road (3.6 m). This caused multiple damages to its central part, between the axes 7 and 11, as it is explicitly depicted in Fig. 2(a). As for Fig. 3(a), it shows that, among the pathologies noted on the bridge, there is an out-of-plane plastic deformation on the central part of the main beam on the southern side. Likewise, Fig. 3(b) shows that part of the lower chord of the beam is plasticized, and even partially torn across its width. In addition, a strong local plastic deformation and some partial fractures appear on the vertical and diagonal members of the panels (5-7, i.e., axes 8-11), as shown in Figs. 3(b)-(d). Furthermore, according to Fig. 3(e), some plastic deformations and separate cracks were concentrated on the lower flanges of the bridge floor beams and the stringers in the central part, i.e., axes 6-10. Moreover, Fig. 3(f) shows the detachment of the decking in the impacted area (axis 8). In addition, corrosion was observed, with varying degrees, on all the elements, but it was particularly noticeable on the area affected by the impact, on the southern side.

Moreover, the findings confirm the damage previously observed, i.e., the out-of-plane deformation of the girder on the southern side, between the axes (7 and 11), the tears on its bottom chord, and the local buckling on the diagonals, as illustrated in Figs. 3(a)-(d).

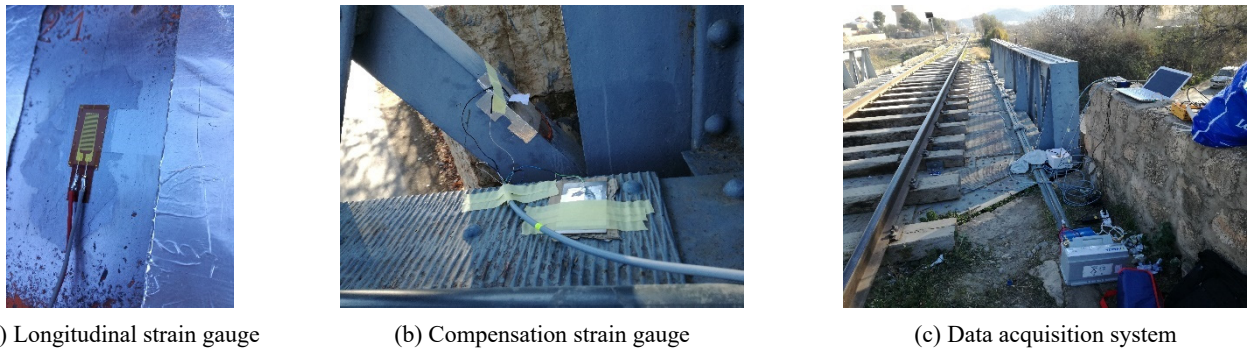
Furthermore, strain measurements were carried out using the HBM linear strain gauges (LY11-10/120) which were mounted in a five-wire half-bridge circuit: one strain gauge in the longitudinal direction of the element, a compensation strain gauge on a separate steel part, not loaded and subjected to the same temperature conditions, as shown in Figs. 4(a)-(b). This configuration allows

Fig. 4 Experimental strain measurement

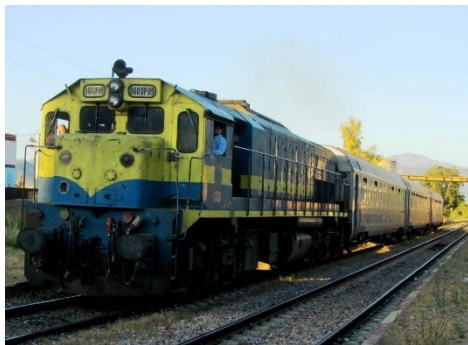
Fig. 5 View of the train travelling along the railway bridge

The rest of the study is based on the data recorded by the eight strain gauges shown in Fig. 2(a) as the passenger train crosses the bridge, as shown in Figs. 5 and 6. This train is composed of a General Motors GT 22 CW locomotive and three passenger cars. Table 1 and Fig. 6 give more details about the train running on the bridge as well as the scheme used for the loads. Fig. 7 presents the normal stress responses calculated from recorded strains over time with respect to the position of the moving load. It is easy to observe the effect of the passage of the moving load of each group of axles. The curves in this figure exhibit a symmetrical behaviour around the considered sections: they increase, as the force gets closer and then start decreasing as they move away from the examined section. The magnitude of stresses changes considerably between the different components.

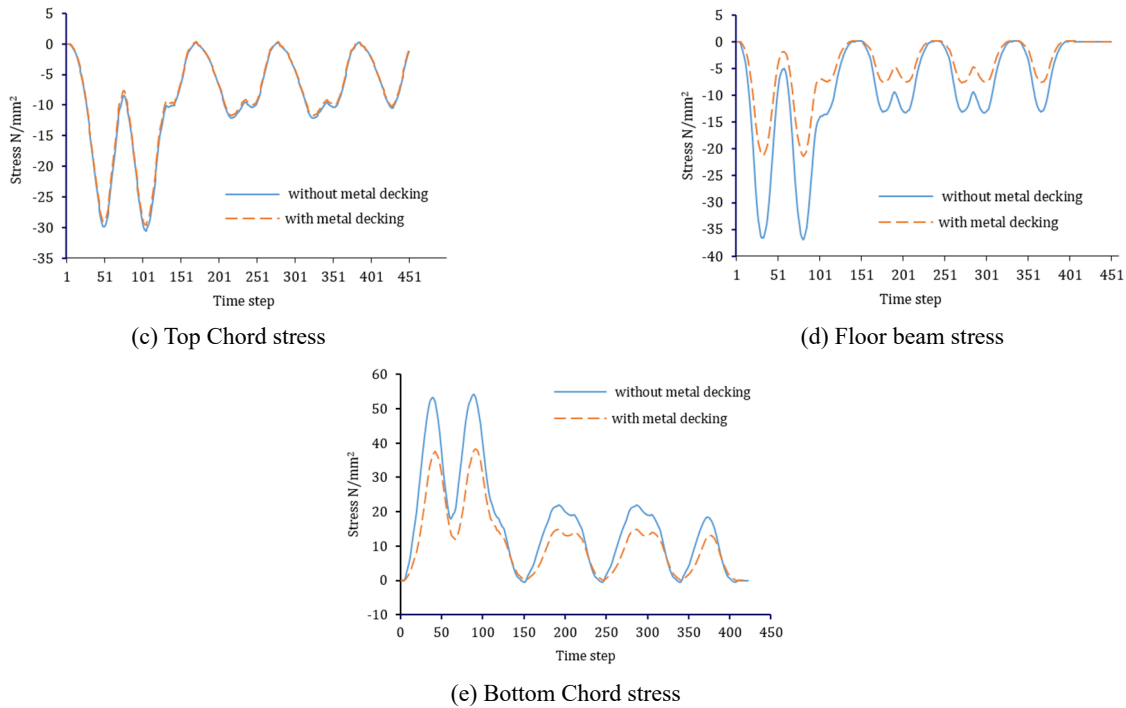
Fig. 10 Finite Element normal stresses – Metal decking effect

exceed 5%. However, the bridge floor beams have a significant effect; the difference can reach 75%, as is clearly depicted in Fig. 10(d). This observation is quite obvious because in the presence of the metal deck plate, the stiffness of the deck increases. In fact, a part of the applied forces is absorbed by the deck, which engenders a drop in the normal stress value. A similar effect was also observed on the bottom chord of the main girders (see Fig. 10). In this case, the difference is estimated at 45%.

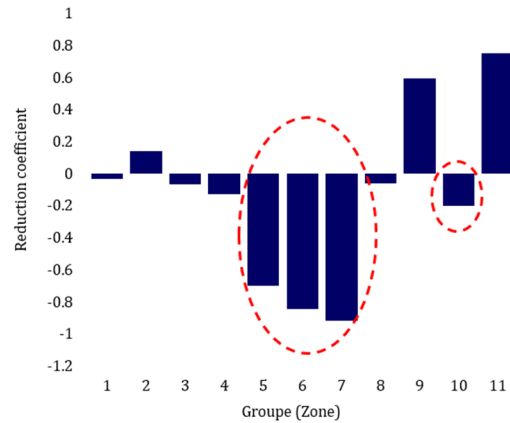
Fig. 14 Reduction coefficients corresponding to each group of elements G1 - G11

As indicated in Fig. 14, the inverse analysis results gave positive correction coefficients, varying from 0.03 to 0.14, in regions 1, 2, and 3 which correspond to the main girder on the north side; this element is not damaged. Furthermore, negative coefficients were observed in zones 4, 5, 6, 7, and 8 that correspond to the beam elements on the south side; these elements were affected by the impact. The negative coefficients are higher in the central part, with a maximum value of -0.91. Table 4 presents the different results and
