## Quantitative scalar damage evolution of fire-exposed reinforced concrete beam using ultrasonic pulses

**Keywords:** fire damage; microcracks; scalar damage; ultrasonic pulses

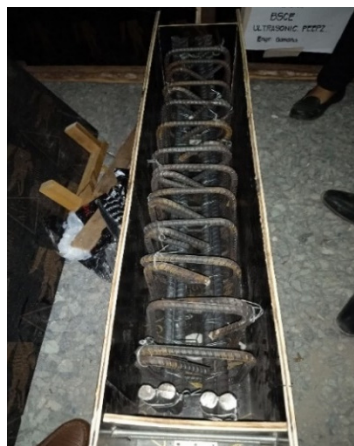
Fig. 1 Deformed Reinforcement Bar inside the beam mold

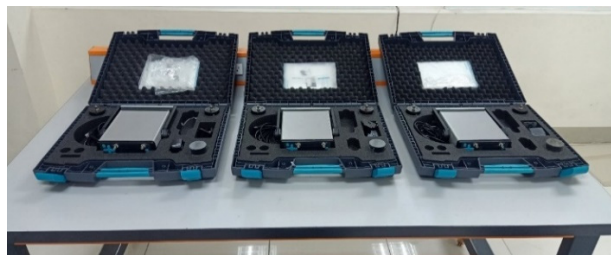
Fig. 3 PUNDIT Lab+ with 54 kHz Ultrasonic Transducers

The UPV devices used in this research are PUNDIT Lab+ with ultrasonic transducers that have a 54 kHz resonating frequency as shown in Fig. 3. The PUNDIT Lab+ is a flexible instrument

primarily designed for laboratory operations, it has a measuring resolution of  $0.1 \mu\text{s}$ , a bandwidth of 20 to 500 kHz, a measuring range of 15 m, and using PROCEQ Punditlink software, it can be remotely controlled using computers with an oscilloscope function. Moreover, this device has a data logging function that eases the data gathering, export, and analysis using third-party software, which minimizes the errors in human interactions.

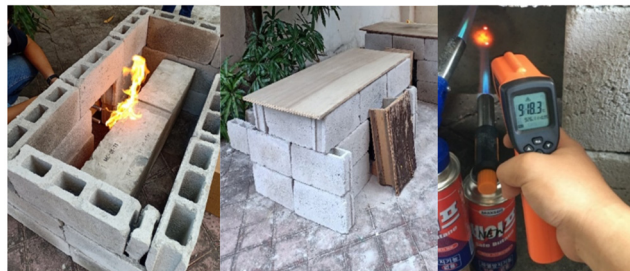
Fig. 4 RC beam inside the fabricated fire furnace

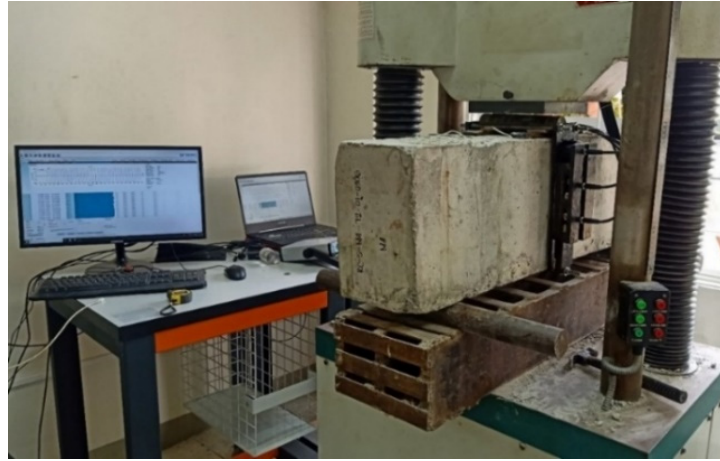
Fig. 5 Destructive flexural test of RC beam while simultaneously measuring the ultrasonic pulses

The measurement of ultrasonic pulses follows the instructions as prescribed by ASTM C597, the standard test method for pulse velocity through concrete, which requires the firm attachment of the ultrasonic transducers to generate a good transmission that can be verified by the PROCEQ Punditlink software when the pulse attenuation is 100%. Since the direct distance between two transducers was initially measured together with the abovementioned PROCEQ Punditlink settings, it will become the input for software to compute automatically the velocity of ultrasonic pulses as well as the decay of their pulse attenuation. Prior to the destructive test, an initial measurement of the UPV and pulse attenuation was conducted with a minimum of 20 readings per device, assuring that no zero readings occurred between the intervals, this is to capture the undamaged properties of the RC beam before loading. Moreover, the setup of the destructive flexural test follows the instructions as prescribed by ASTM C293, the standard test method for the flexural strength of concrete using a simple beam with center-point loading. Furthermore, ultrasonic pulses are simultaneously measured using the data logging mode of the UPV device together with the UTM load until RC beam failure, as shown in Fig. 5.

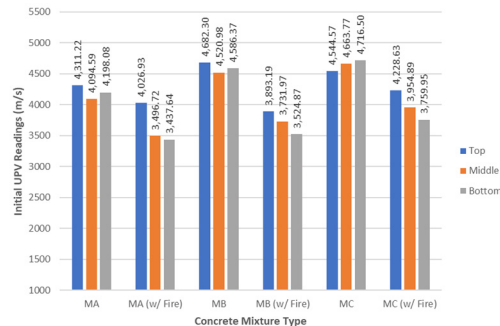
Fig. 6 Initial UPV reading to Concrete mixture type with and without fire exposure

The subsequent discussions present the initial UPV readings of the concrete mixture with and without fire exposure as shown in Fig. 6. It can be observed that the bottom transducer experienced the largest reduction in UPV readings with an average of 20.51% as compared to the top and middle transducers with an average reduction of 10.13% and 15.75%, respectively. Both bottom and middle transducers accumulated larger fire damage as compared to the top transducer since the fire torches were placed directly to the bottom and near the middle transducer, making the temperature from these locations beyond 900°C while quite less for the top transducer, these findings are aligned with the literature as mentioned earlier that concrete exposed to a higher temperature will experience higher fire damage due to dehydration and decarbonization of cement binders in addition to rapid evaporation of water that leads to the formation of cracks networks. Moreover, based on the initial UPV reading without stress application, there is no significant relationship that exists with respect to the concrete strength and steel ratio, which is also consistent with the study of Yang *et al.* (2009).

Hence, this phenomenon might be the effect of the research setup since the beam is under the discontinuity region where, instead of failing under the pure flexure, an internal strut develops in the concrete that directly transfers the forces to the reinforcement that served as the tension member to maintain equilibrium, commonly known as the “Strut-and-tie model”. In addition, both top and middle transducers are subjected to compression stresses, with the middle transducer exposed to higher fire damage than the top transducers, as shown in Fig. 6.

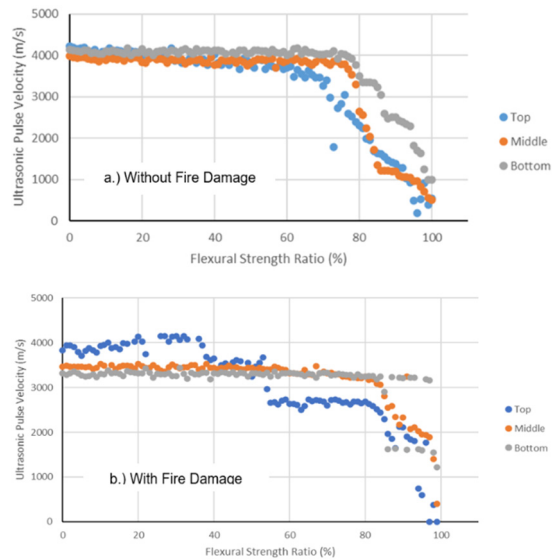
Fig. 7 UPV Readings to Flexural Stress-Strength ratio of RC Beam (RC-S-MA-T1)

Meanwhile, Fig. 7(a) presents the UPV Readings to the Flexural Stress-Strength ratio of the RC beam without fire damage, while Fig. 7(b) presents the RC beam with fire damage; the trends as observed in these figures are consistent with the eight other average graphs that exhibit the same trends. It is observed that for both conditions the degradation of the top transducer starts at lower stress levels such as 72% for the beam without fire damage while 54% for the beam with fire damage as compared to the middle and bottom transducers where drastic deterioration normally starts beyond 80% stress level, this signifies that with respect to the nature of stress, concrete under compression accumulates severe damage as compared to the concrete under tension at earlier stress, this result is counter-intuitive since the author expects that concrete under tension will be the first to show damage since concrete is much weaker in tension than in compression stress.

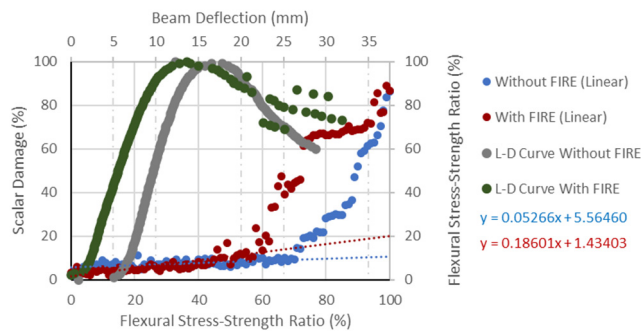
Fig. 10 Scalar Damage and Beam Deflection to Flexural Stress-Strength ratio of RC Beam (RC-S-MA-T3)

In Figs. 8-16, the correlation between concrete strength, scalar damage, and flexural stress-strength ratio is clearly depicted. Figs. 9 and 11 compare concrete mixtures A and B at a steel ratio of 1.812%, while Figs 10, 12, and 14 compare mixtures A, B, and C at a steel ratio of 2.435%. In contrast, Figs 13 and 15 compare mixtures B and C at a steel ratio of 3.797%. These figures demonstrate that concrete strength influences damage propagation: higher concrete strength leads to earlier significant deterioration of the scalar damage variable relative to the flexural stress-strength ratio, with a decrease in the inclination angle. This behavior is attributed to the brittle nature of concrete, constrained by a strain limitation of 0.003, as discussed in the literature. Despite increased beam capacity with higher concrete strength, the strain limit occurs at lower stress levels, indicating a reciprocal relationship between concrete strength and strain limitation.

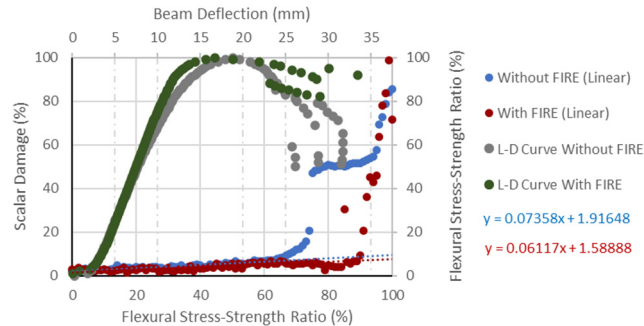
Fig. 16 Scalar Damage and Beam Deflection to Flexural Stress-Strength ratio of RC Beam (RC-S- MC-T3)

In summary, Figs. 8-16 illustrates the relationship between the steel ratio and the slope of the elastic data trend. As the amount of steel reinforcement increases, the slope decreases. For instance, beams exposed to fire under concrete mixture A show inclination angles of  $16.370^\circ$ ,  $11.082^\circ$ , and  $10.537^\circ$  with steel ratios of 1.208%, 1.812%, and 2.435% respectively. Similarly, beams exposed to fire under concrete mixture B exhibit angles of  $7.885^\circ$  and  $4.374^\circ$  with steel ratios of 1.812% and 3.797% respectively. For concrete mixture C, angles are  $14.059^\circ$ ,  $10.006^\circ$ , and  $3.500^\circ$  with steel ratios of 2.435%, 3.797%, and 5.150% respectively. Moreover, the effect of the nature of the applied stress is significantly affected by the amount of reinforcement as observed, data showed that the transducers under compression stress deteriorate earlier as compared to transducers under tension since the concrete under tension stress starts to deteriorate consequent to rebar yielding as shown in Fig. 7. Although the concrete under compression stress deteriorates earlier, the concrete under tension drastically deteriorates at a higher stress level after the rebar yielding, as shown in the steep slope of the bottom data series. Furthermore, the additional reinforcement bar stiffened the concrete's response to tension stresses where the bottom transducers were placed, since the drastic deterioration of the bottom transducer becomes even closer to ultimate strength as the steel ratio increases. This additional stiffness is also shared for the concrete compression part, where the top and middle transducers were attached. This behavior is a brittle response and critical since there is no warning prior to the sudden collapse. Furthermore, this research reinforced the American Concrete Institute (ACI) code principles that limit the amount of steel ratio to assure the beam's ductility to the applied load.
