# Evaluation of failure mode of tunnel-type anchorage for a suspension bridge via scaled model tests and image processing

**Abstract.** In this study, the pull-out behavior of a tunnel-type anchorage for suspension bridges was investigated using experimental tests and image processing analyses. The study focused on evaluating the initial failure behavior and failure mode of the tunnel-type anchorage. In order to evaluate the failure mode of tunnel-type anchorage, a series of scaled model tests were conducted based on the prototype anchorage of the Ulsan Grand Bridge. In the model tests, the anchorage body and surrounding rocks were fabricated using a gypsum mixture. The pull-out behavior was investigated under plane strain conditions. The results of the model tests demonstrate that the tunnel-type anchorage underwent a wedge-shaped failure. In addition, the failure mode changed according to the differences in the physical properties of the surrounding rock and the anchorage body and the size of the anchor plate. The size of the anchor plate was found to be an important parameter that determines the failure mode. However, the difference in physical properties between the surroundin

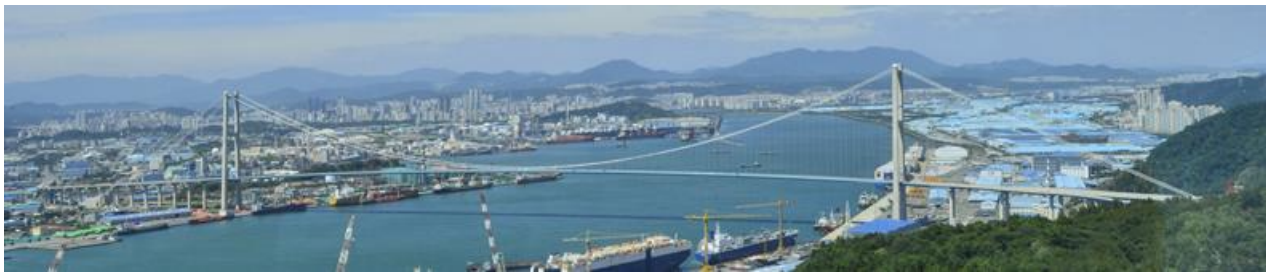
(a) Actual view

(b) Schematic diagram

Fig. 2 The Ulsan Grand Bridge

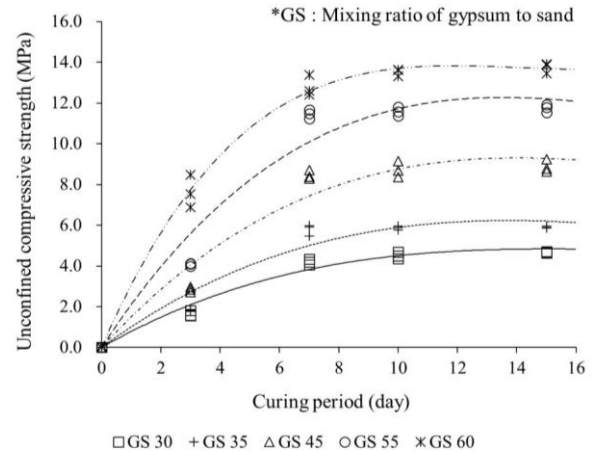
Fig. 4 Unconfined compressive strength of gypsum mixtures with curing time where GS is the ratio of gypsum to sand (wt%)

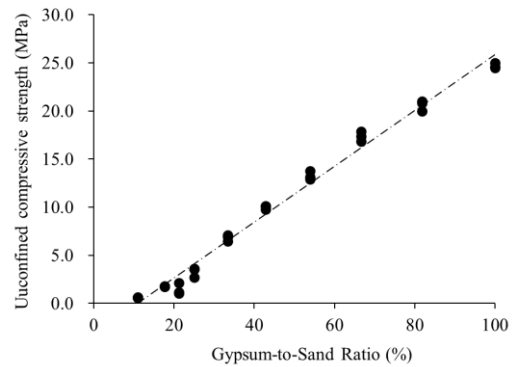
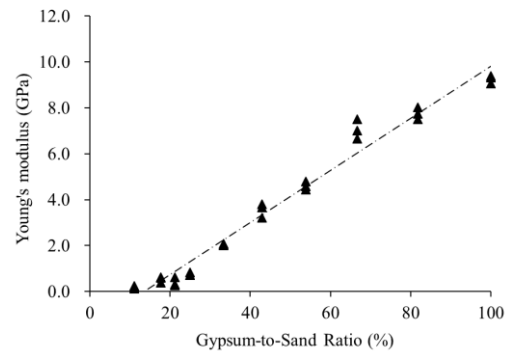
(a) Unconfined compressive strength

(b) Young's modulus

Fig. 5 Relationship between the physical properties and gypsum-to-sand ratio

of the physical property test, which were analyzed using linear regression analysis, showed that the compressive strength and deformation modulus were significantly correlated with the gypsum/sand mixing ratio (Fig. 5). Meanwhile, when the proportion of gypsum was low, the actual physical properties of the rock mass could hardly be simulated, and the uniform physical properties could not be reproduced because of the high moisture content, which can considerably affect the accuracy of the test. Strength ranging from 0.5 to 1 MPa was required to match the scaled physical properties of the model rock mass and anchorage model materials. However, the strength range of approximately 0.5 to 1.1 MPa was used according to the aforementioned constraints. The mixing ratios of sand, gypsum, and water used for the composition of the model rock mass and anchorage body materials are summarized in Table 2 (Yooshin Co., Ltd. 2010b).

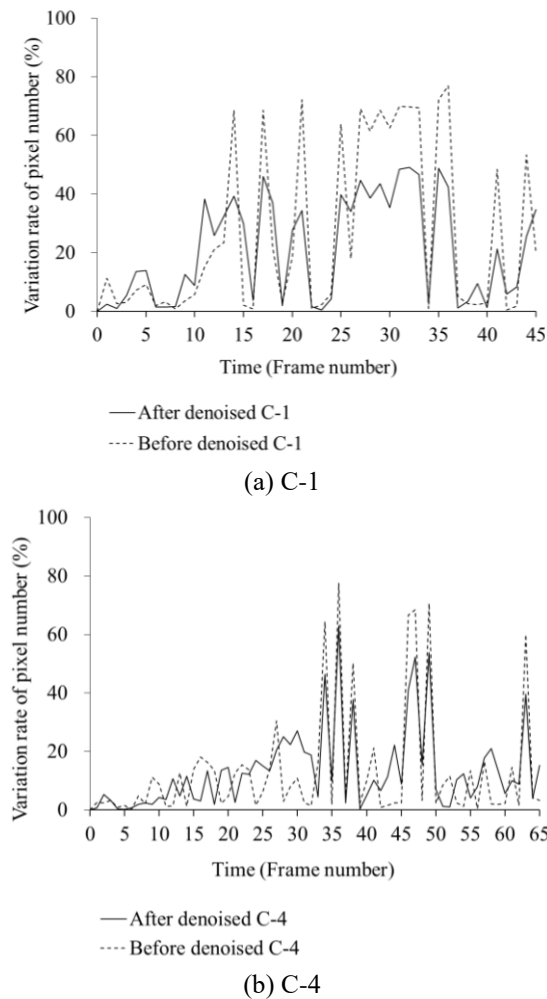
Fig. 16 Comparison of pixel variation before and after noise reduction using the median filter

To minimize the noise in the collected images, a median filter was applied during pre-processing. The median filter is advantageous in that the deterioration of the edge is relatively small among the nonlinear filtering algorithms (Cho *et al.* 2010, Pratt 1978), and edge detection is important for identifying cracks. As shown in Fig. 16(a), for C-1, after the noise was removed using the median filter, the number of pixels counted was lower, but the tendency is similar (though it exhibits slight differences in relative magnitude). It is thus considered that the application of the median filter increased the detection rate of initial fine cracks.

In addition, the results of denoising the data for C-4 using the median filter show a similar tendency (Fig. 16(b)). Thus, even if the failure mode cannot be observed with the naked eye because of the influence of the measurement equipment or experimental environment, it is possible to quantitatively evaluate failure propagation using the image processing-based method proposed in this study.
