Numerical analysis and stability assessment of complex secondary toppling failures: A case study for the south pars special zone

Abstract. This article assesses and estimates the progressive failure mechanism of complex pit-rest secondary toppling of slopes that are located within the vicinity of the Gas Flare Site of Refinery No. 4 in South Pars Special Zone (SPSZ), southwest Iran. The finite element numerical procedure based on the Shear Strength Reduction (SSR) technique has been employed for the stability analysis. In this regard, several step modelling stages that were conducted to evaluate the slope stability status revealed that the main instability was situated on the left-hand side (western) slope in the Flare Site. The toppling was related to the rock column-overburden system in relation to the overburden pressure on the rock columns which led to the progressive instability of the slope. This load transfer from the overburden has most probably led to the separation of the rock column and to its rotation downstream of the slope in the form of a complex pit-rest secondary toppling. According to the numerical modelling, it was determined that the Strength Reduction Factor (

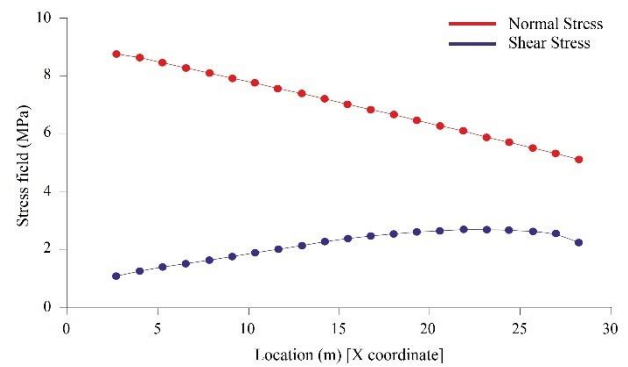
Fig. 14 The stress field variation in the slope mass

Fig. 14 provides the stress field status in the slope that is subjected to toppling failure. As seen in this figure, the normal stress is reduced towards the slope face whereas the shear stress displayed an opposite behaviour. This phenomenon verified that complex pit-rest secondary toppling was triggered by shear stresses.

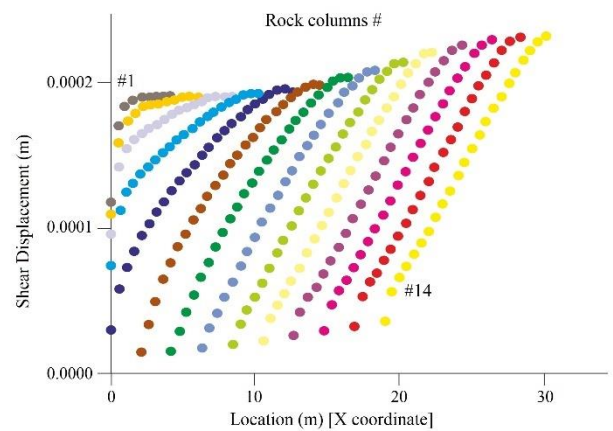
Fig. 15 The shear displacement variation in the slope mass (note: “#” represents the rock slab number)

Toppling failure is initiated by the increase of shear displacements in the rock columns that lead to the overturning of the rock blocks and rotation about the base. A plot of the shear displacement for each slab is presented in Fig. 15. As seen in this figure, the shear displacement increased towards the surface of the rock columns.

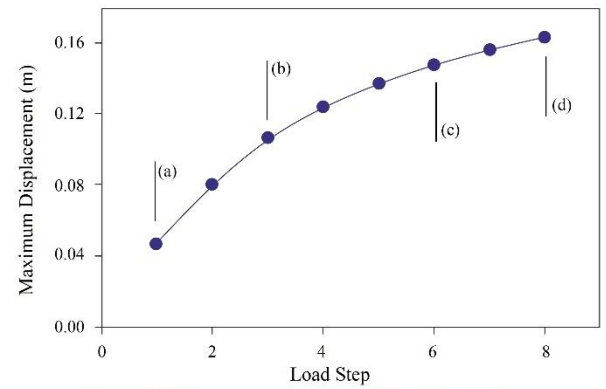
Fig. 19 Progressive failure in rock slope based on the load-displacement diagram

The most important cause of progressive toppling failure in the region is the complex geostructure. In this regard, the instability process can be divided in various stages such as initial condition, sliding, flexural bending, toppling, and downfall. Thus, each stage can be considered as a triggering factor for the next stage until massive movement occurs. The variation of the maximum loading versus displacement could give a hint on the progressive process in toppling. Fig. 19 illustrates the loading condition on the slope with respect to displacement until the final stage. As seen in this figure, the main displacement started in the overburden (on the upper part of the slope) and triggered rock slabbing (towards the slope toe) movement. Thus, the instability increased and was maximized in the final stage. According to Fig. 19(a), the instability has concentrated towards the top of the slope where the overburden consists of weak and weathered materials (see Fig. 4). The instability has increased as the load increased and has spread towards the front of the slope that resulted in the pushing of the rock columns that caused overturning (Fig. 19b). This stage is considered as the starting point of toppling failure. Increased displacement with increased load led to local instability and progressive toppling failure as shown in Fig. 19c.
