Analysis of the buckling failure of bedding slope based on monitoring data - a model test study

Qian Zhang¹, Jie Hu^{*2,3}, Yang Gao¹, Yanliang Du¹, Liping Li³, Hongliang Liu³ and Shangqu Sun⁴

Keywords: buckling failure; critical load; model test; monitoring data; slope

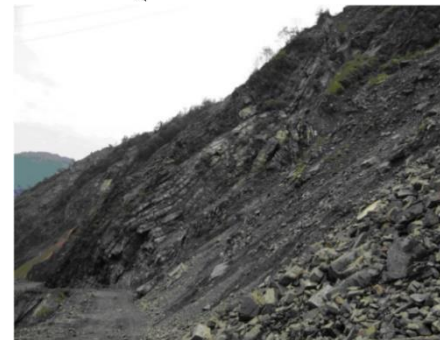
Fig. 2 Schematic of buckling slope failure and example of slope undergoing buckling failure in southwestern (Qi *et al.* 2015)

Landslide disasters caused by instability of the bedding slope are most common in mountainous areas. In the traditional view, a steeply inclined bedding slope is stable. As the research on the instability mechanism of the slope deepens, more and more slip-buckling failures have been found in high-steep slopes, such as Jipazi landslide, Bawang Mountain landslide, and Dashankou landslide in southwestern China; typical buckling failure is shown in Fig. 2. Slip-buckling slope failure often occurs when the

The tests conducted in this study were designed to examine stress, strain, and displacement of slope under loading, and then to study the mechanism of buckling failure. Also, the thickness of the slipping mass (“h” shown in Fig. 2) was set as 15 cm, 20 cm, and 25 cm to study the critical load of buckling failure corresponding to different thicknesses (h_1 , h_2 , h_3), as shown in Fig. 10. Two monitoring sections were selected in the x-direction and displacement, strain, and stress of the rock mass were monitored in each section. The spacing between adjacent monitoring components of the same monitoring content is set as 5 cm. The monitoring scheme was shown in Fig. 11.

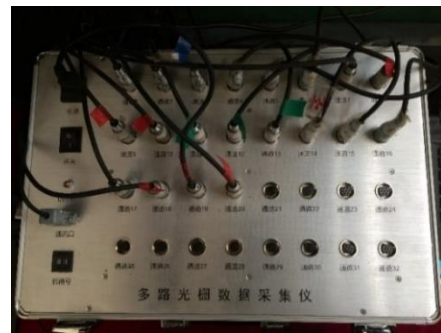
Fig. 7 Strain monitoring system: (a) strain sensor of Fiber Bragg grating and (b) data acquisition system

Strain sensing bars based on Fiber Bragg Grating (FBG) technology were used to measure the strain of the rock mass. The FBG strain test system features a small disturbance on the stress field of model rock, high measurement accuracy, continuous measurement, and strong anti-interference ability, which isn't easy to be disturbed by external factors, such as electromagnetic and temperature. The fiber strain bricks are 3 cm × 3 cm × 3 cm cubes made of similar materials, and fiber optics are pasted in the direction of 45° on the surface of bricks, as shown in Fig. 7(a). The monitoring data were acquired by the data acquisition system shown in Fig. 7(b).

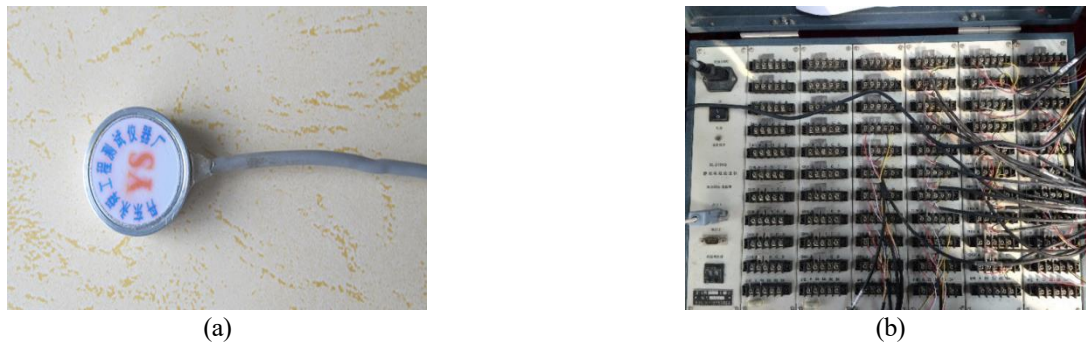
Fig. 9 Stress monitoring system: (a) pressure cell of resistance type and (b) data acquisition system

The stress of rock mass in slope was measured using a resistance type pressure cell, as shown in Fig. 9(a). The size of the pressure cell is $\Phi 17 \times 7$ mm, and the measurement range is 0 ~ 1 MPa. The data acquisition system was shown in Fig. 9(b).

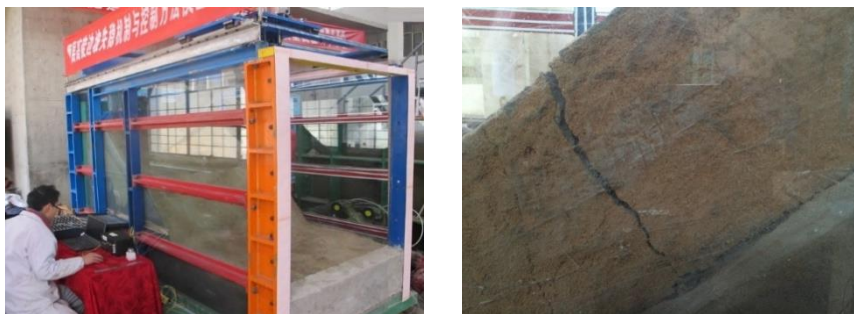
Fig. 14 (a) The overall model test system in the loading process and (b) The typical failure in the loading process.

slipping mass reached failure in each test condition, the failure was identified mainly based on the obvious cracks or buckling of the slipping mass. The monitoring data were measured in real-time under each loading and the displacement, stress, and strain of rock mass were analyzed when the data stabilized. The progression of buckling failure is monitored during the loading process to determine when the next loading should be carried out. The overall model test system in the loading process can be seen in Fig. 14(a) and the typical failure phenomenon was shown in Fig. 14(b).
