Application of UAV images for rainfall-induced slope stability analysis in urban areas

Abstract. This study evaluated slope stability through a case study to determine the disaster risks associated with increased deforestation in structures, including schools and apartments, located in urban areas adjacent to slopes. The slope behind the OO High School in Gwangju, Korea, collapsed owing to heavy rain in August 2018. Historically, rainwater drained well around the slope during the rainy season. However, during the collapse, a large amount of seepage water flowed out of the slope surface and a shallow failure occurred along the saturated soil layer. To analyze the cause of the collapse, the images of the upper area of the slope, which could not be directly identified, were captured using unmanned aerial vehicles (UAVs). A digital elevation model of the slope was constructed through image analysis, making it possible to calculate the rainfall flow direction and the area, width, and length of logging areas. The change in the instability of the slope over time owing to rainfall lasting ten days before the collapse was analyzed through numerical analysis. Imaging techniques based on the

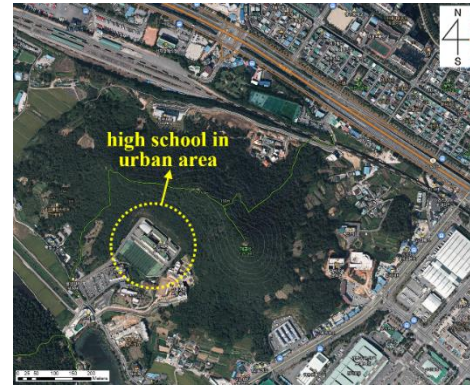
Fig. 3 Location of a high school and the adjacent area in Gwangju (UAV image)

Fig. 3 shows a UAV image of the high school and the adjacent area in Gwangju where a slope failure occurred, and

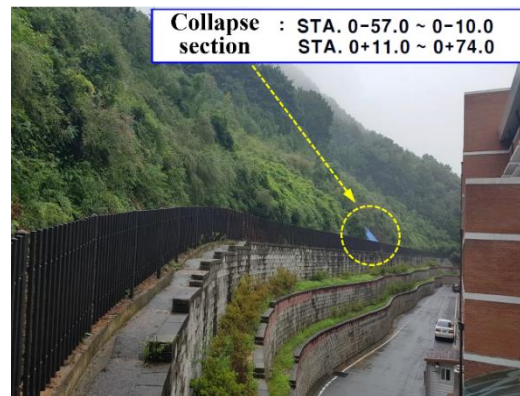
Fig. 4 Slope failure site behind the high school building

Fig. 4 shows the location of the collapse of the retaining wall slope behind the high school building. The area covered by blue tarpaulin is the area where the collapse occurred (Fig. 4). The failure occurred in the soil layer; however, there was no damage to the retaining wall structure. Fig. 5 shows a cross-section of the slope reinforcement design. The site slope was steeper (1:1.7 to 1.4) than a standard slope (1:1.2 to 1.5), and many traces of scouring in the form of shallow failures owing to heavy rainfall were found.

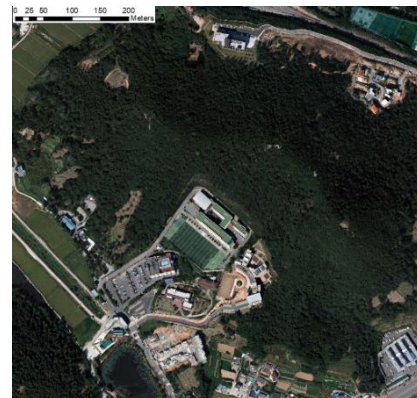
Fig. 6 Area surrounding the high school photographed by a UAV (Sept. 2015)

The slope behind the high school collapsed on August 31, 2018, due to heavy rainfall. However, as shown in Fig. 6, it has been a stable area without collapse every year, although it has rained a lot during the rainy season for more than a decade. Rainwater resulting from heavy rainfall was drained effectively near the retaining walls every year; however, a sudden slope failure occurred during the rainy season of 2018. Thus, images of the area surrounding the slope were captured using drones to determine the cause of slope failure. Based on these images, several areas in the

upper regions of the slope, where bushes and trees had been logged, were identified. Figs. 6-8 can easily be found on general internet mapping sites. The aerial photographs, captured and recorded every two years, show that the logged sections existed in 2017, at least one year before the collapse. As seen in Fig. 7, the four slopes marked by yellow dotted lines show the areas where bushes and trees were logged compared to the same areas in 2015 (Fig. 6). Further logging areas can be seen from the image in 2019 (Fig. 8).

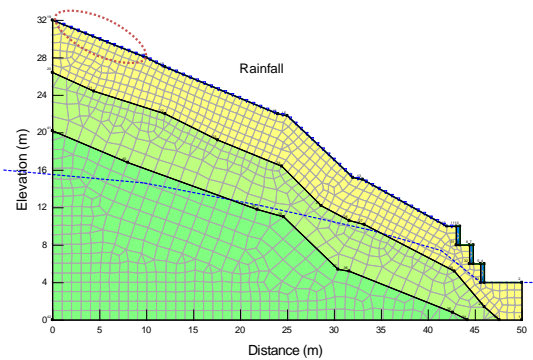
Fig. 14 Initial condition for unsaturated soil seepage analysis (SEEP/W)

For the initial numerical analysis conditions with rainfall exceeding the permeability coefficient and occurring on a slope with dense bushes or trees, the ponding effect is not generally considered because the rainfall flows along the terrain surface. In this study, the area in Fig. 14 marked by a red dotted line was defined as a logging section, and the ponding effect was considered. In the event of rainfall exceeding the saturated permeability coefficient, the daily rainfall penetrating the ground and affecting slope stability was analyzed over time. The boundary conditions were set according to the retaining wall design conditions, as shown in Fig. 15, and the slope stability was examined in connection with seepage analysis for ten days.

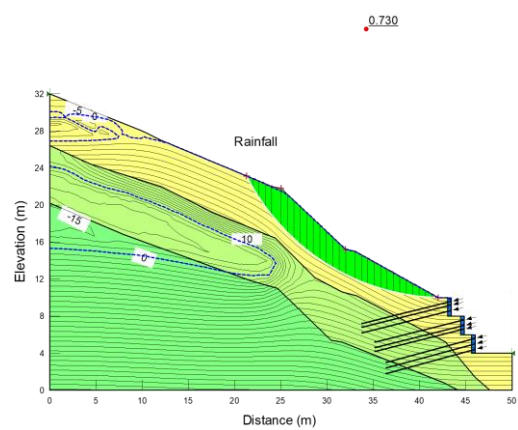
Figs. 16-23 show the results of the seepage analysis that applied the daily rainfall conditions shown in Fig. 13. The results could not be presented for all dates. The pore water pressure distribution in the ground, depth of saturation from the surface layer, and safety factor of each slope were determined for days 1, 3, 5, and 10. As rainfall begins, the seepage water flowing along the unsaturated surface depends on the unsaturated permeability coefficient calculated by the soil-water characteristic curve (SWCC, as shown in Table 1). The unsaturated permeability function of weathered soils is the most important hydraulic property governing the flow process. Therefore, various information of the unsaturated permeability function is essential in the

Table 2 summarizes the safety factor of the slope according to the daily rainfall for ten days. According to the seepage and stability analyses, a failure had already occurred after five days. Although the collapse was found at the site on August 31 (the tenth day), we surmise that the slope failure had already begun in the upper part of the slope after five days. We consider that the surface layer was rapidly saturated because large amounts of water penetrated the ground owing to logging and that the ground strength decreased relatively quickly as the pore water pressure increased and matric suction rapidly decreased (Saseendran and Dodagoudar 2020, Song and Hong 2022, Zhang *et al.* 2015, Zhao *et al.* 2020).
