# Assessing influence of waves on riverbank stability: A centrifuge modeling approach

**Abstract.** Erosion along riverbanks stands as a critical natural disaster, severely impacting the economy and livelihoods of those near rivers. The erosion occurs from the weakening and displacement of materials along the bank, driven by various elements such as water flow, ship-generated waves, agricultural practices, and nearby infrastructure. The soil-water interface presents a complex challenge, sparking extensive studies into understanding the interplay between hydrodynamic forces and soil properties. This research focuses on assessing how water waves influence riverbank stability. Through a series of centrifuge experiments, it investigates the relationship between wave-induced dynamic pressure and erosion rates. Findings suggest that the wave height of 0.22 to 0.24 meters on the prototype scale can be simulated under a 20 g artificial acceleration in the centrifuge modelling. The erosion process develops in three distinct phases: initial erosion, formation of tension cracks, and eventual collapse, underscoring the practical importance of understanding wave pressure and soil resistance to

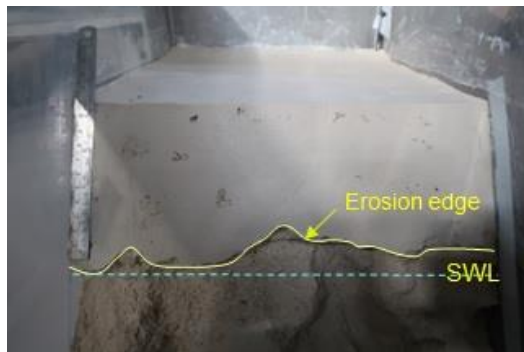
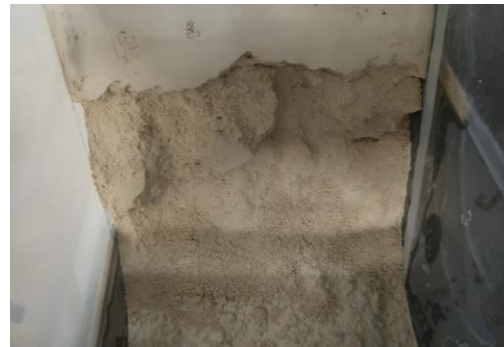
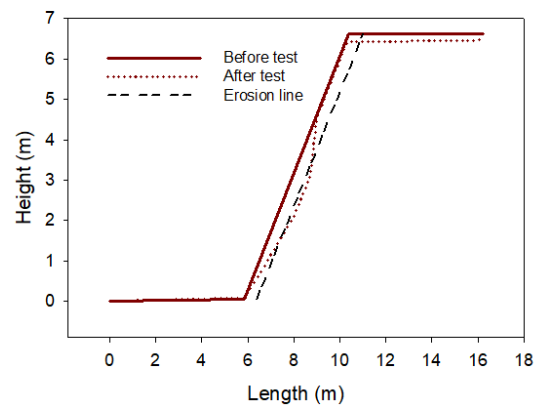
Fig. 11 The failure of riverbank after test

This section presented the outcomes of erosion tests, including ES, EML, EL, and EC, encompassing details such as process failure, erosion rate, failure shape, and safety factor. In the “EC” experiment involving clay material, 30% sand and 70% clay were used to prepare the model. The results indicated that erosion occurred below the water level, as depicted in Figs. 11(a) and 11(b). The entire test spanned one hour in model scale (20 hours in prototype), and no tension cracks appeared on the surface. Notably, the erosion process did not cause damage to the soil above the water level. The riverbank surface experienced erosion of approximately 0.3 m to 0.6 m (equivalent to 0.045 H to 0.09 H) in the prototype scale, measured from the original surface. A scanner was employed to assess the alteration in the slope surface before and after the test. Post-testing settlement reached 10 mm in the model, equivalent to 0.2 m in the prototype (Figs. 11(c) and 11(d)). The failure surface was identified at the slope's toe, and the erosion distance was indicated by the black dash-line, marking the deepest point of erosion. The collapse of the slope soil amounted to 9.4% (0.47% per hour) in planar strain relative to the slope section.

(a) Top view

(b) Front view

(c) The scanning results in 3D (in model scale)

(d) The erosion line after test (in prototype scale)

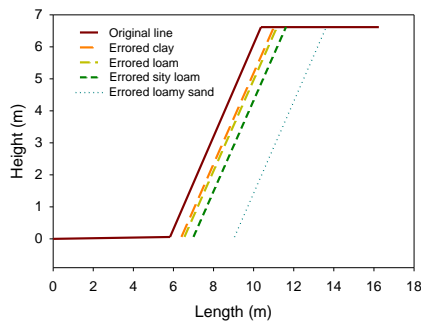
Fig. 13 Eroded line

Fig. 13 displays the eroded line assumed at the deepest washing point of the surface slope after the test. The results indicated that the soil with a higher percentage of grain content, like "loamy sand, ES" with 80% of sand, was eroded deeper than the soil with a high percentage of fine content (clay and loam). However, the different percentages of sand in "loam" – 40 % and "clay" – 30 % did not significantly affect the erosion distance ( $D$ ); the ratio was approximately  $0.09 H$  to  $0.1 H$ . However, the "silty loam" with 20% of sand exhibited an erosion distance ( $0.2 H$ ) larger than the "clay, EC" and "loam, EL" materials. This difference was attributed to the lower percentage of clay

Consequently, the percentage of grain content significantly affected the erosion process of the riverbank. Under wave conditions (short-term condition), the limitation of material was less than 40 % of sand and higher than 20 % of clay to contribute positively to the slope stability. This suggested that the materials with a higher proportion of sand exhibited a more considerable erosion distance than those with a lower percentage of sand.

Utilizing the erosion distance as a basis, a simple model was developed to establish a relationship between the erosion distance ( $D$ ) and the percentage of clay, expressed by the following equations. Consequently, a decrease in the percentage of clay corresponded to an increase in the erosion distance. It was worth noting that this relationship exhibited a non-linear nature.

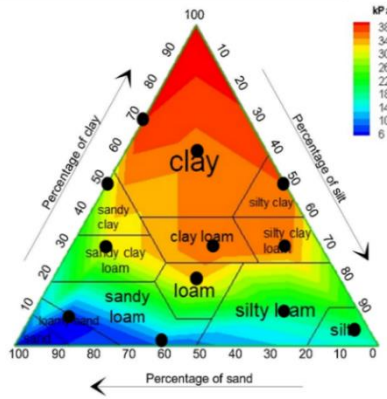
Fig. 15 Soil strength

Figs. 15 and 16 presents the critical erosion distance determined by considering both soil strength. Notably, the critical erosion distance within the "clay zone" surpassed that of the "loam zone" and "sand zone," exceeding 2 meters. Conversely, the critical erosion distance in the sand zone was less than 1 meter due to the absence of cohesion in this soil type (sand zone, silt zone). Furthermore, within the "silty loam" category, those with lower silt composition exhibited a larger critical erosion distance (1-2 meters) than those with higher silt composition, with less than one meter of critical erosion distances. These distinctions arose from variations in soil composition.

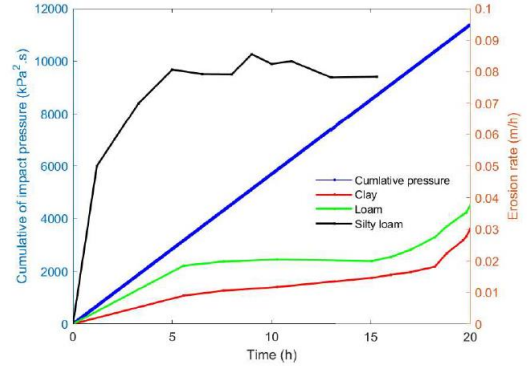
Fig. 17 The relationship between erosion rate and cumulative of impact pressures

The erosion rate was determined by establishing a correlation between impact pressure and the soil's strength, as illustrated in Fig. 17. Consequently, under a dynamic pressure of 28 kPa and a monitoring duration of 20 hours, the erosion rates for "clay", "loam," and "silty loam" were found to be 0.03 m/h, 0.0375 m/h, and 0.078 m/h, respectively. The relationship between erosion rate and impact pressure exhibited an inverse trend; as the impact pressure increased, the erosion rate decreased.

The cumulative impact pressure was employed as a simplifying factor in the estimation process to address this complexity. Subsequently, a simplified model was proposed to establish the relationship between the erosion rate and cumulative of wave impact pressure, expressed by the following equation.

$$\varepsilon_t = a \times \left( \frac{\int |P(t)|^2 dt}{S_u} \right)^b \quad (4)$$

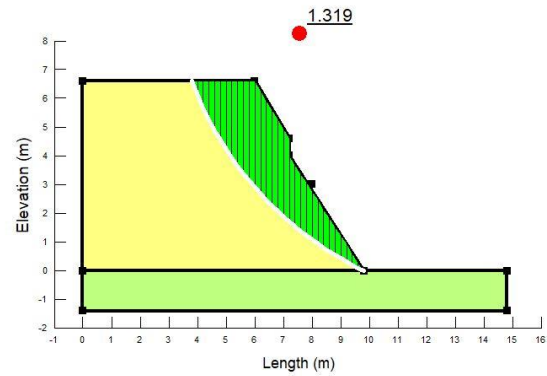
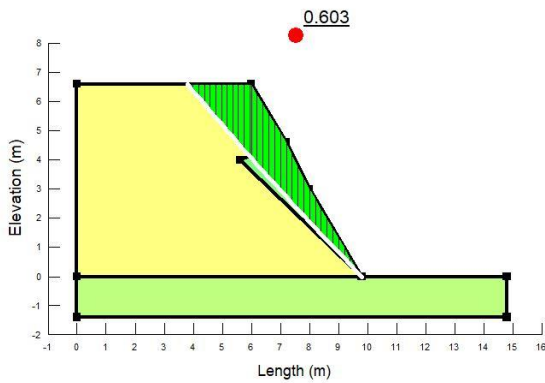
Fig. 18 The safety factor of slope with different erosion depth

Numerical simulation was employed to assess the safety factor of the model both before and after testing under a stable water level condition. The numerical model simulated changes in slope geometry based on erosion distances observed during testing, with the initial slope depicted as Fig. 18(a) in the prototype scale. In the "EC" test, two materials, encompassing clay and bedrock, were input into the numerical model. Clay simulated the slope material in the centrifugal test, while the bedrock was the container's bed, controlling the slip failure surface that did not extend beyond the slope's toe. Consistent control was applied to the entrance and exit of the slip failure surface across all models, facilitating easy comparison of safety factor variations. In the post-centrifugal test slope geometry represented by Figs. 18(b) and 18(c), with the erosion distance of 0.6, 2.4 m, the safety factor analyzed by the numerical model was 1.319, 0.603, respectively. Notably, the erosion distance was arbitrarily selected to calculate the safety factor.

Consequently, the erosion process has not impacted global failure at present. The assumed erosion distance was introduced to identify the critical erosion. The safety factor increased from 1.311 to 1.319 before and after erosion (0.6 m). However, as the erosion distance extended to 2.0 m, the safety factor decreased to 1.255 and dropped below 1.0 at 2.2 m. Fig. 18(d) presents the safety factor and erosion distance in four types of material. The safety factor was equal to one when the erosion distance was equal to 0.8 m, 1.2 m, and 2.1 m, corresponding to silty loam, loam, and clay material.

(a) The original slope (EC-model)

(b) The slope with the erosion depth of 0.6 m (EC-model)

(c) The slope with the erosion depth of 2.4 m (EC-model)

(d) The safety factor during process failure

Table 4 displays the outcomes obtained through three distinct approaches: centrifuge modeling, numerical simulations, and theoretical results. For silt loam material, the erosion distance remained consistent across all three approaches. However, for clay and loam, the centrifuge model tests did not reach the failure stage, resulting in non-equivalent erosion distances compared to numerical simulations and theoretical predictions. The new formula was employed to predict the eroded distance for clay and loam materials. Consequently, the critical erosion distances for clay and loam were determined to be 2.1 m and 1.4 m after 70 hours and 40 hours, respectively. This emphasizes the effectiveness of the centrifuge model in accurately simulating wave conditions, providing valuable insights into erosion dynamics for different soil types.
