# Study on collapse mechanism and treatment measures of portal slope of a high-speed railway tunnel

**Abstract.** The slope of an open cut tunnel is located above the exit of the Leijia tunnel on the Changgan high-speed railway. During the excavation of the open cut tunnel foundation pit, the slope slipped twice, a large landslide of 92500 m<sup>3</sup> formed. The landslide body and unstable slope body not only caused the foundation pit of the open cut tunnel to be buried and the anchor piles to be damaged but also directly threatened the operational safety of the later high-speed railway. Therefore, to study the stability change in the slope of the open cut tunnel under heavy rain and excavation conditions, a 3D numerical calculation model of the slope is carried out by Midas GTS software, the deformation mechanism is analyzed, anti-sliding measures are proposed, and the effectiveness of the anti-sliding measures is analyzed according to the field monitoring results. The results show that when rainfall occurs, rainwater collects in the open cut tunnel area, resulting in a transient saturation zone on the slope on the right side of the open cut tunnel, which reduces the shear str

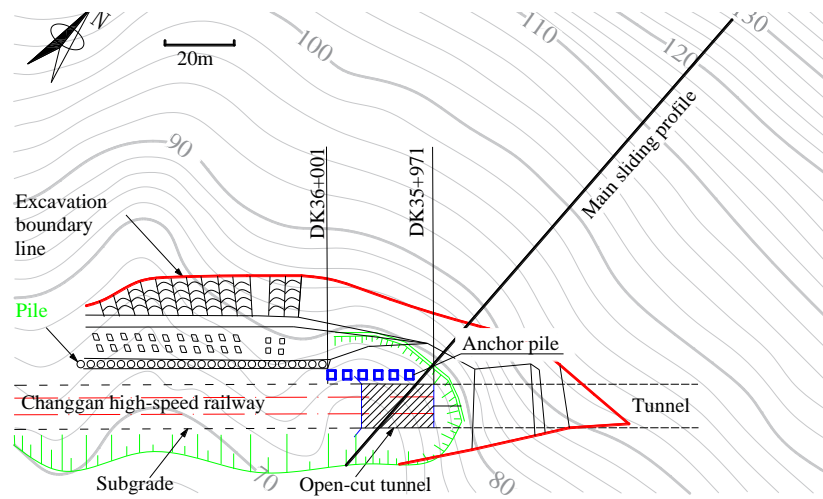
(a) Original design of the slope

The mileage of the Leijia tunnel exit (road and tunnel boundary) is DK36+001, the mileage of the boundary between the open cut tunnel and dark tunnel is DK35+971, and the length of the open cut tunnel section is 25 m; the slope ratio of the upward slope at the entrance of the tunnel is 1:1.25, which is protected by frame anchor bolts, and the mountain on the right side of the open tunnel is protected by anti-slide piles; the slope ratio above anti-slide piles is 1:1.5, and the primary slope is protected by anchor bolt frame beams; the first level slope is protected by anchor bolt frame beams, and the second level slope is protected by an arch skeleton, as shown in Fig. 2(a).

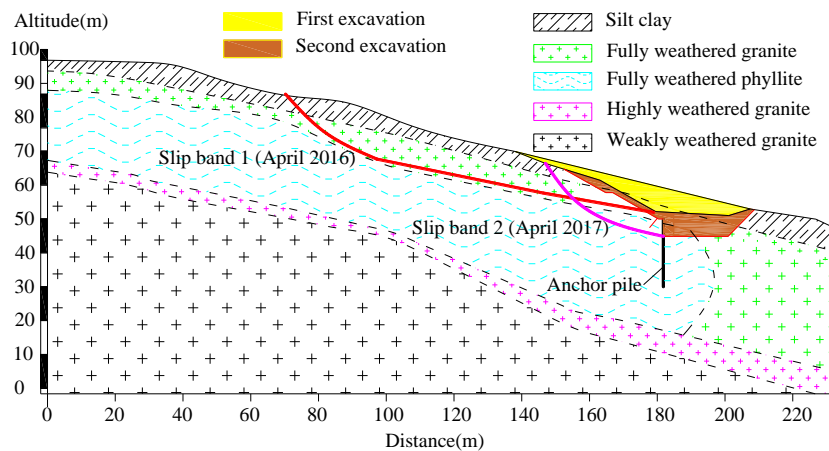
(b) Longitudinal section of the slope

According to the survey, the surface of the site is distributed with quaternary eluvial deluvial strata, and the underlying bedrock is Proterozoic phyllite and late yanshanian granite. The details of the strata from top to bottom according to their age and genesis are as follows: quaternary holocene eluvial diluvium, silty clay, fully weathered granite, fully weathered phyllite, highly weathered phyllite and weakly weathered phyllite, as shown in Fig. 2(b).

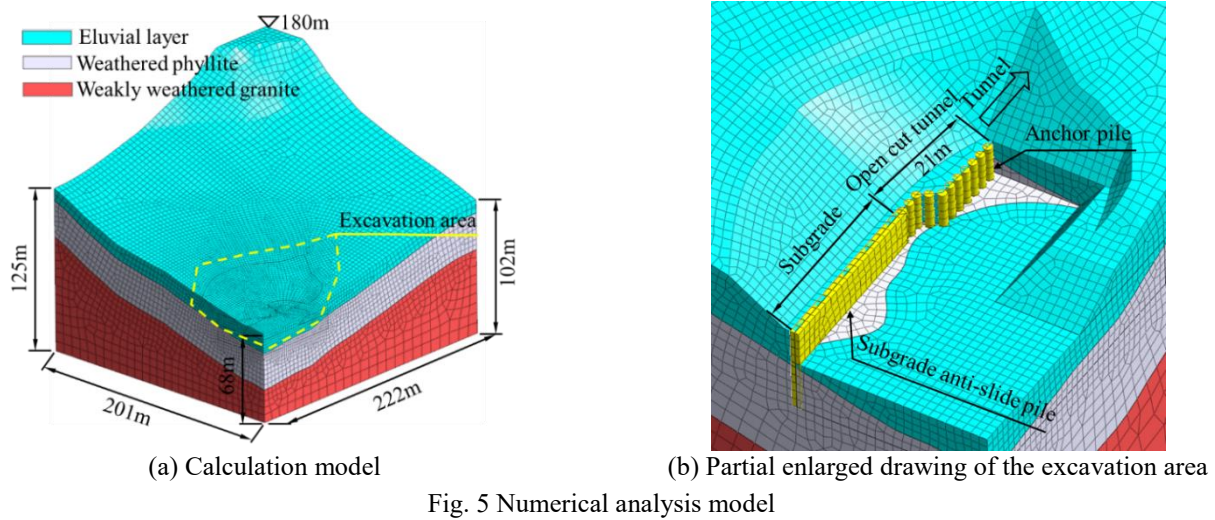
Fig. 5 Numerical analysis model

The numerical model is established according to the actual landform and geological conditions of the slope, as shown in Fig. 5. The calculation model contains 75290 nodes and 126948 elements. The rock and soil are simulated by Mohr Coulomb elastic-plastic constitutive model, and the pile is simulated by elastic constitutive model. Solid element is adopted for rock and soil, beam element is adopted for pile, and beam element and truss element are adopted for anchorage section and free section of anchor cable respectively.

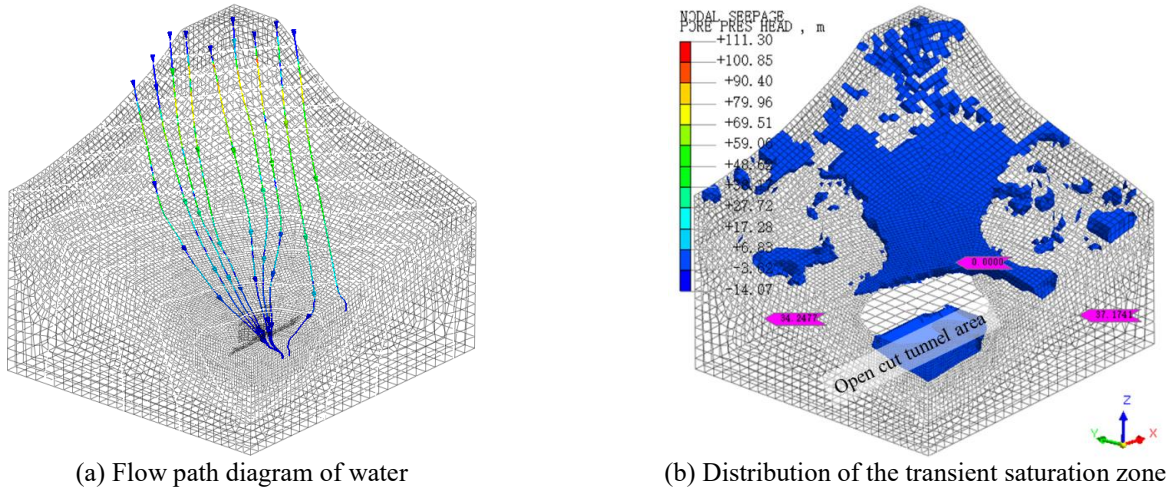
Fig. 6(a) shows that on mountains, when rainfall occurs,

Fig. 6 Distribution of flow path and transient saturation zone

the water on the slope converges along the slope to the area where the tunnel is located while seeping downward. The field survey shows that there are several water outlets at the lower part of the slope when continuous rainfall occurs, which indicates that the calculated results are basically consistent with the actual results. Fig. 6(b) shows the distribution of the transient saturation zone of the slope on April 10 and 26. The figure shows that after three consecutive days of rainfall, several saturation zones appear on the slope, and the saturation

areas are mainly concentrated in the open cut tunnel area and its upper area, which is basically consistent with the sliding area found on site.

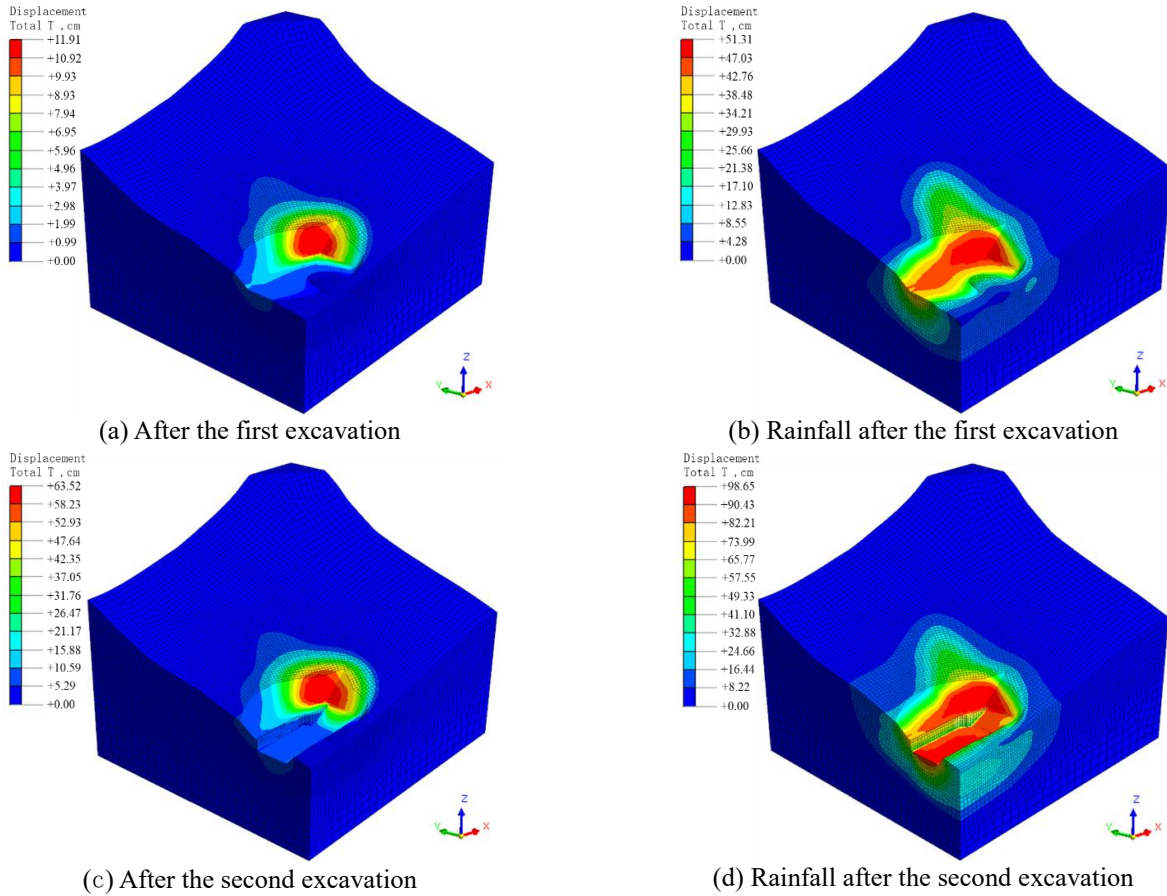
Fig. 7 Slope deformation under different working conditions

Fig. 7 shows the overall displacement contour distribution of the slope after being affected by excavation and rainfall. Fig. 7(a) shows the deformation of the slope when the topsoil in the

location of the open cut tunnel is excavated. At this time, the area of slope deformation is mainly near the open cut tunnel, the maximum displacement is 11.91 cm, and the deformation in other areas is small. Fig. 7(b) adds the rainfall calculation based on the first excavation calculation, and the maximum displacement value of the slope is 51.31 cm, which is significantly larger than that without rainfall, and the deformed area is also enlarged; its shape is basically the same as that of the site survey in Fig. 4. Fig. 7(c) shows the deformation of the slope after the anchor pile is constructed and the second excavation is carried out. The maximum displacement of the slope is 63.52 cm, which is slightly larger than that in Fig. 7(b). Fig. 7(d) shows the deformation of the slope after rainfall again, and the maximum displacement of the slope is 98.65 cm.

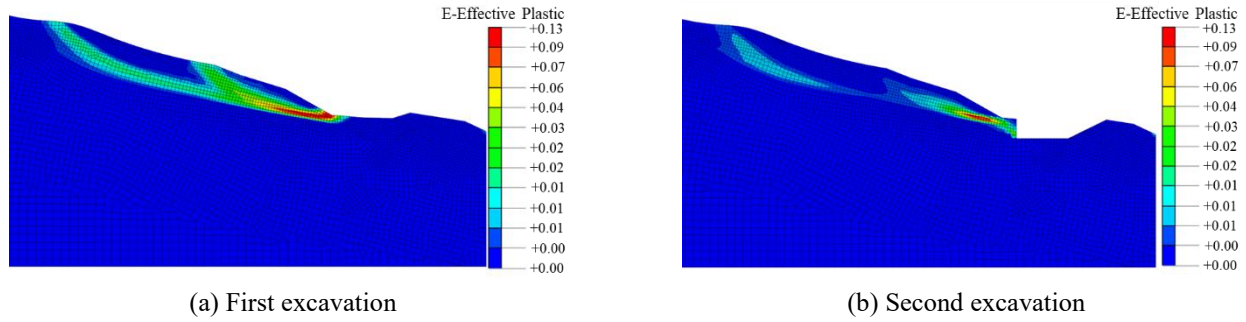
Fig. 8 Variation in the plastic zone of the slope

2002). Fig. 8(a) shows that within the first excavation, due to rainfall infiltration and soil excavation, an obvious plastic zone appeared on the upper layer of the slope, and two potential sliding surfaces appeared, which basically matched the field monitoring results in Fig. 4. Fig. 8(b) shows the distribution of the plastic zone of the slope after the secondary excavation of the soil. The figure shows that the position of the plastic zone of the slope is mainly concentrated in the toe area, which is deeper than the position of the plastic zone calculated by the first excavation.

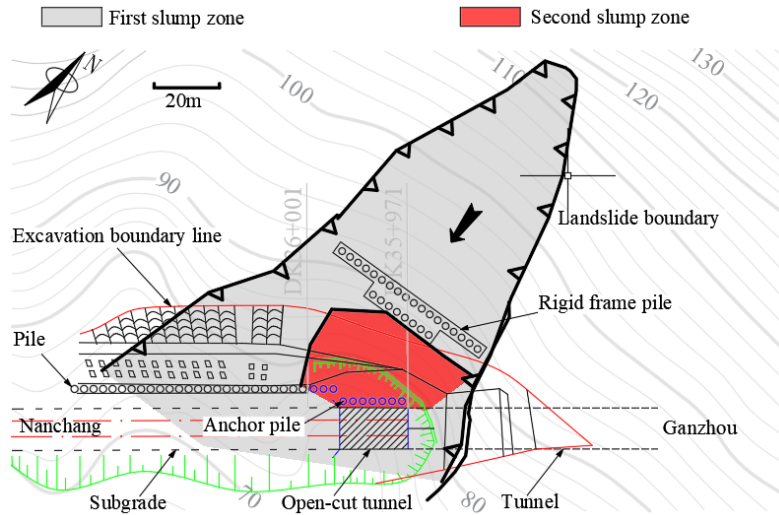
Fig. 11 Design of reinforcement measures

calculation and analysis results, there are two potential sliding surfaces on the slope, and reinforcement measures should be designed for the two potential sliding areas. In view of the construction flexibility of anti-slide piles, different forms of anti-slide piles are designed at the middle and toe of the landslide according to the anti-slide requirements, and mortar anchor bolts are constructed on the slope.

The designed anti-slide rigid frame pile is shown in Fig. 11. Its specific parameters are as follows: the pile material is C35 concrete, the pile length is 24 m and is composed of two piles with a single length of 12 m, the diameter of the pile is 2 m, the pile spacing between the two piles is 2 m in the transverse direction and 5 m in the longitudinal direction, and a crown beam is set at the top of the pile; the thickness of the crown beam is 1.5 m.

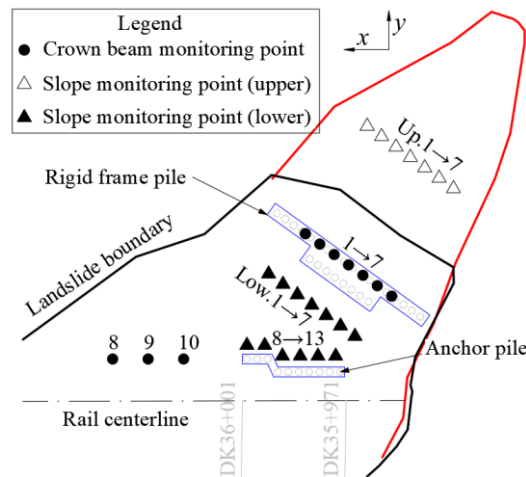
Fig. 12 Layout of displacement monitoring points on slope and anti-sliding pile

monitoring points are arranged on the upper part of the landslide mass, thirteen displacement monitoring points are arranged on the lower part, and ten monitoring points are arranged on the pile top beam, as shown in Fig. 12. The monitoring time intervals of the surface displacement are generally 1 day.

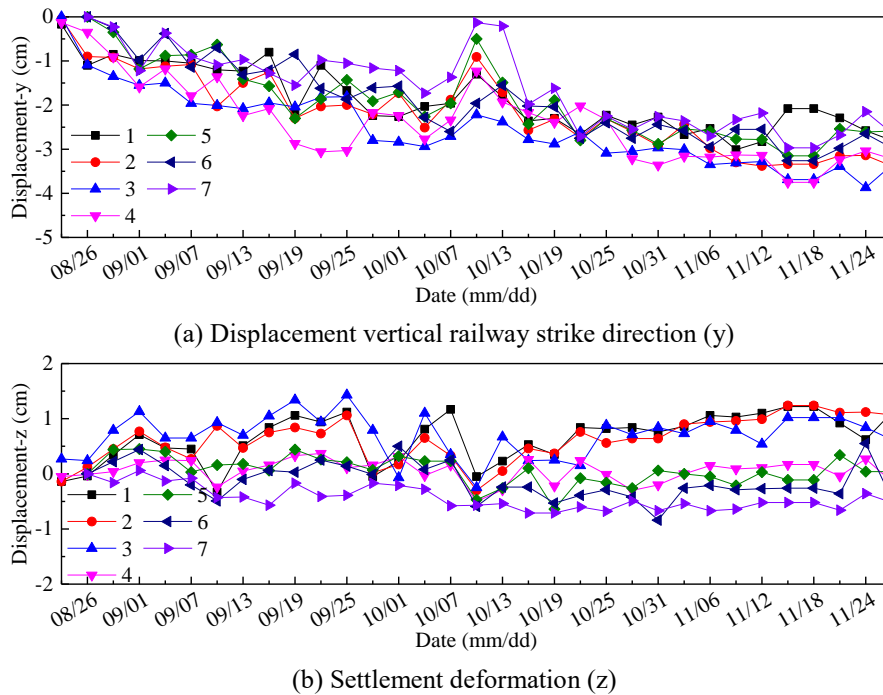
Fig. 13 Monitoring results of the displacement of the top beam

Fig. 13 shows the displacement of the anti-slide pile top beam in both the vertical railway strike direction and settlement. During the whole monitoring process, the deformation of the anti-slide pile itself was relatively small, the maximum horizontal displacement value of its top was 3.36 cm, and the maximum settlement value was only 0.52 cm.

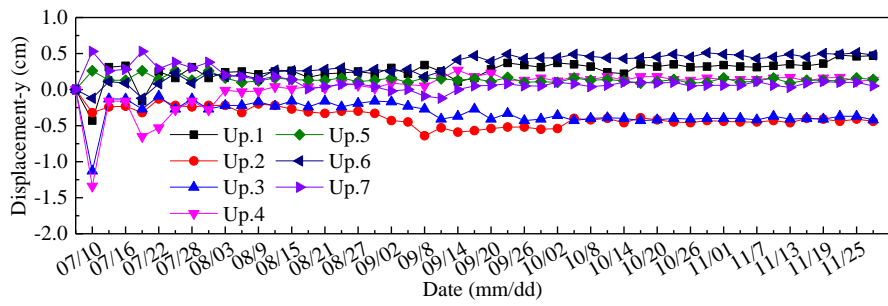
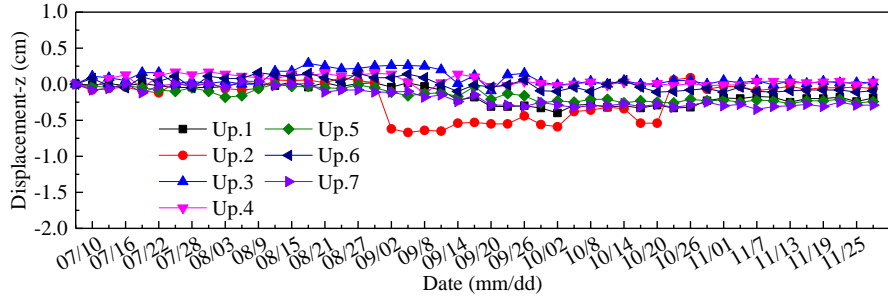
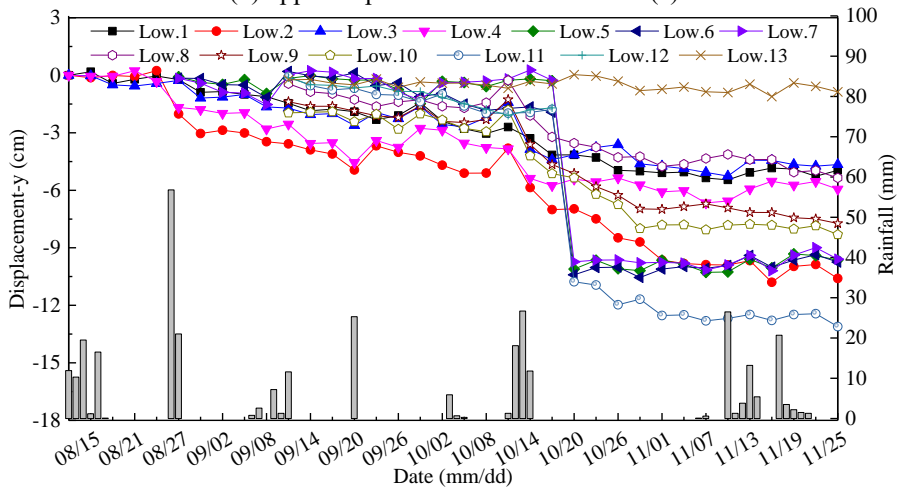
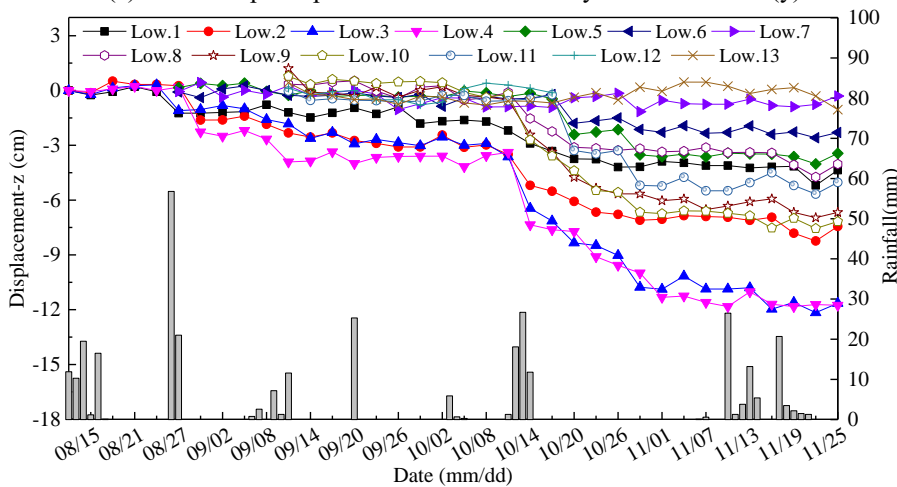
Fig. 14 Monitoring results of the slope surface displacement points

Fig. 14 shows that the deformation of the upper part of the slope is obviously smaller than that of the lower part. The lower slope has a large deformation, the maximum horizontal displacement value is 13.11 cm, and the maximum settlement value is 11.76 cm. During the monitoring process, there were two obvious increases in the data, which occurred from August 23 ~ August 25 and from October 11 ~ October 13. According to the meteorological monitoring records of the site, the daily rainfall on August 24 reached 56.8 mm, and the cumulative rainfall from October 11 to 13 reached 56.6 mm. Clearly, rainfall has a great influence on the deformation of the tunnel portal slope.

Fig. 14 shows that the slope was basically stable on November 1, and the on-site slope has not been deformed thus far, indicating that the abovementioned treatment measures are basically effective.
