Automated inspection method for reused temporary equipment members using 3D shape measurement

Abstract. As the members of temporary structures at construction sites are generally reused, inspection of individual temporary equipment members before use is essential to ensure safety during construction. Visual inspection, which is a common practice for assessing the quality of reused temporary equipment, is labor-intensive and depends on the skill of the inspector; thus, automated and accurate inspection methods are desired. However, little research has been devoted to the development of such methods. Because inspection criteria are mostly relevant to deformation, the shape measurement of temporary equipment members is the most fundamental consideration. This paper proposes an automated inspection method for temporary equipment based on measured 3D (three-dimension) shapes. A hardware system with a laser profiler and motion stage was designed to automatically measure 3D shapes. The 3D shape of each member has damage characteristics, such as hole deformation, thread abrasion, excessive clearance, and dents. Damage-detection algorithms for each inspection criterion were developed using

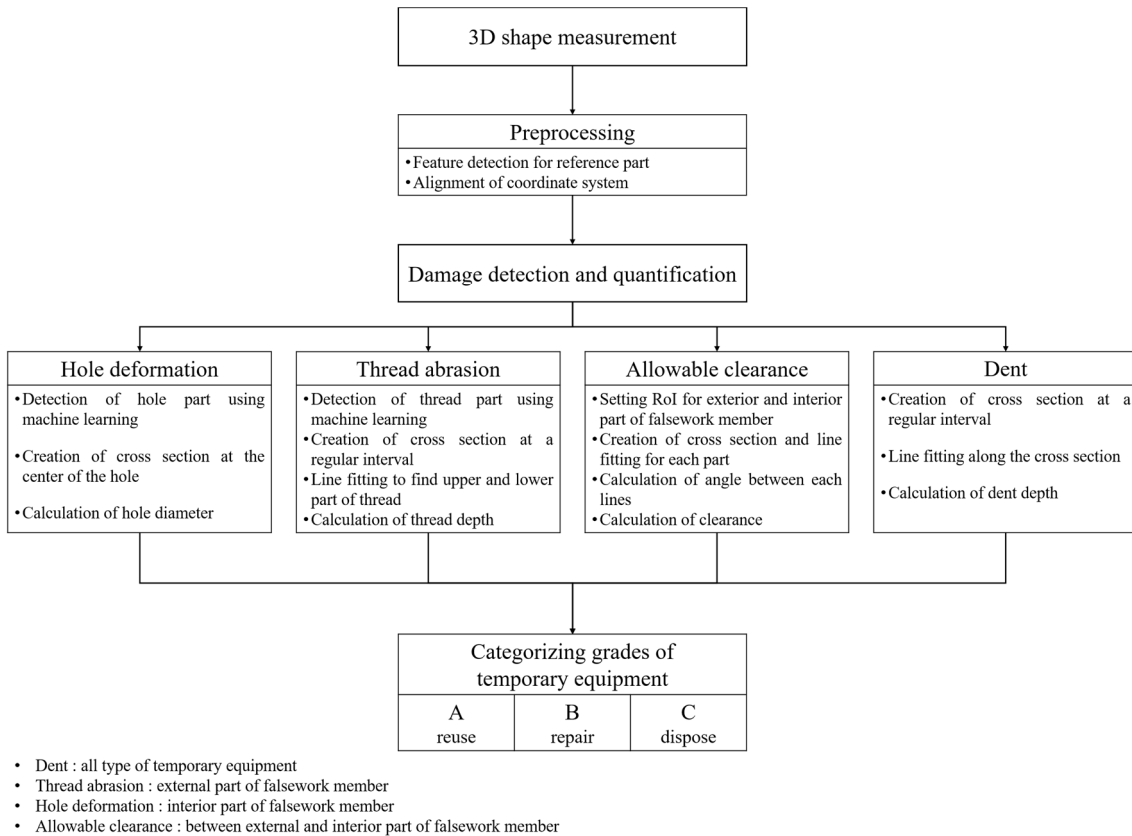
Fig. 6 Flowchart of damage detection algorithms

Damage detection algorithms tailored to each type of damage selected in this study were developed to assess the quality of temporary equipment according to the criteria described in Table 2. A flowchart of the damage detection method is shown in Fig. 6. After completing the shape measurement process described in Section 3.1, the measured 3D shape data, including the projection of the entire registered range-image onto the xy -plane and arrangement of the coordinate system, was pre-processed. Damage detection and quantification were performed for each damage type, including dents, hole deformation, excessive clearance, and thread abrasion, by utilizing the geometric features of the 3D shape and projected range-image. Finally, the grade of the temporary equipment, used for further quality management, was determined. The
