Investigation of the behavior of a tunnel subjected to strike-slip fault rupture with experimental approach

Abstract. In the studies on fault dislocation of tunnel, existing literatures are mainly focused on the problems caused by normal and reverse faults, but few on strike-slip faults. The paper aims to research the deformation and failure mechanism of a tunnel under strike-slip faulting based on a model test and test-calibrated numerical simulation. A potential faulting hazard condition is considered for a real water tunnel in central Yunnan, China. Based on the faulting hazard to tunnel, laboratory model tests were conducted with a test apparatus that specially designed for strike-slip faults. Then, to verify the results obtained from the model test, a finite element model was built. By comparison, the numerical results agree with tested ones well. The results indicated that most of the shear deformation and damage would appear within fault fracture zone. The tunnel exhibited a horizontal S-shaped deformation profile under strike-slip faulting. The side walls of the tunnel mainly experience tension and compression strain state, while the roof and floor of the tunnel would be i

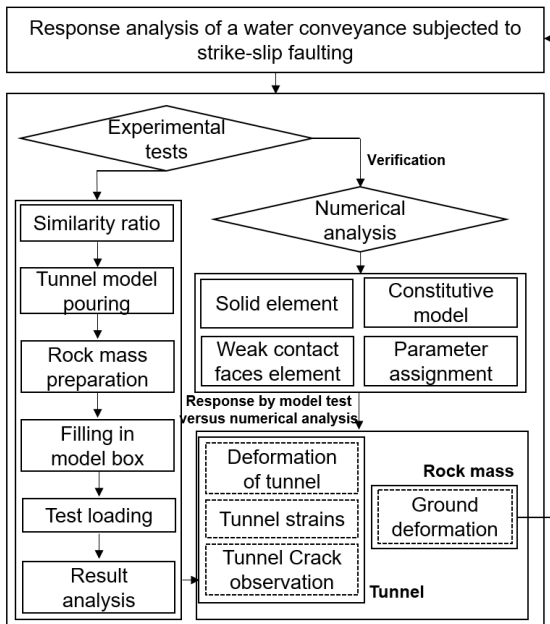
Fig. 1 Flow chart for the research of tunnel response under strike-slip faulting

Overall, the limited knowledges in strike-slip fault dislocation mechanism and tunnel damage attribute to insufficient concerns. Research concerning the physical scaled model test for tunnels across a strike-slip fault has been seldom reported. In this study, based on a real prototype water conveyance tunnel in China, a scaled model test was performed for a tunnel model under the loading of strike-slip fault dislocation. The deformation of rock mass and tunnel, and crack propagation of tunnel were measured. Based on the test data, a 3D numerical model was built. In conjunction with the experimental and numerical results, the response mechanism and failure feature of the tunnel were revealed furtherly when the strike-slip fault dislocation appeared in the stratum. A flow chart has been drawn below to illustrate the logic of this study, as shown in Fig. 1.

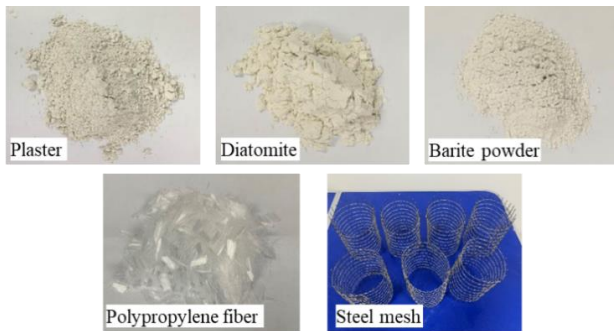
(a) Materials of the tunnel model

The rock mass was also compounded as tunnel material. Fine sand, sodium silicate, barite powder and water would be used here with a mass ratio of 1: 0.1: 0.6: 0.1, while less sodium silicate was added in component of fault fracture zone for the fracture features with a mass ratio of 1: 0.04: 0.6: 0.1 following the order of rock mass. The component materials for tunnel and rock mass have shown in Fig. 3.

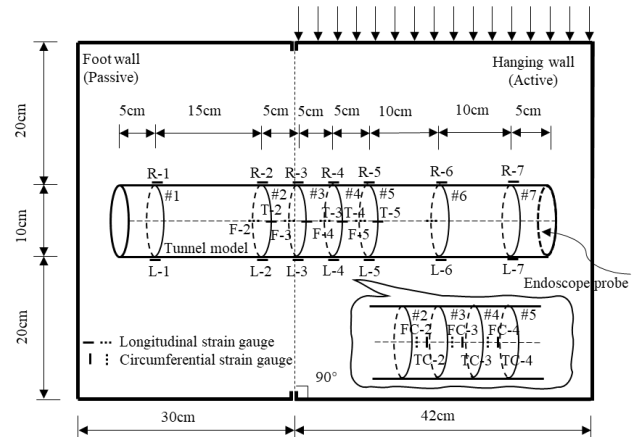
Fig. 5 Layout of the strain gauges

collect strains during the test. The layout of the strain gauges was plotted in Fig. 5.

The strain gauges were stucked on the outer surface of this tunnel model following Fig 4. Seven sections for measurement were designed from no. 1 to no. 7. Meanwhile, #2 ~ #5, were considered as the critical sections for measurement owing to the severe damage and deformation of the tunnel near fault. Strain gauges were arranged to the arch, crown, left and right sidewalls labelled as T, F, L, R, TC, FC, in which TC and FC were circumferential strain gauges while the others were longitudinal strain gauges. Necessary calibration to the strain gauges and temperature compensation have been made to ascertain the accuracy of the test.

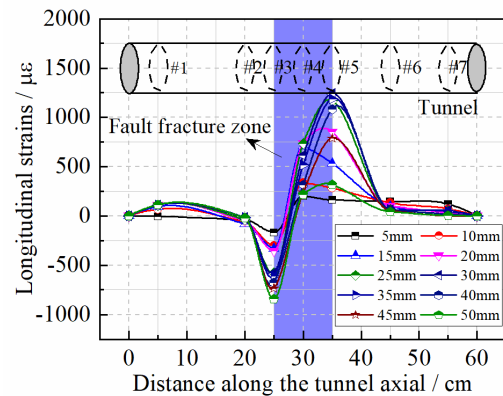
(a) Strains in the left side wall

Fig. 7 Variation of the longitudinal strains in the tunnel side walls with faulting (tension: + compression: -)

Fig. 7 shows the longitudinal strains in the tunnel side walls. For the left side wall, the liners at Section #2 and #3 were in a compression state, while that of Section #1, #4, #5, #6, and #7 were in a tension state.

The maximum compression strain occurred at Section #3 while the maximum tension strain occurred at Section #5. By observing the evolution of the strains with faulting distance, one can notice that the strains at Section #3 and #5 barely increased after the faulting distance reached 25 mm. This indicated that the left side wall of the tunnel began to yield after the faulting distance reached 25 mm, corresponding to a 2.5 m faulting for the prototype tunnel.

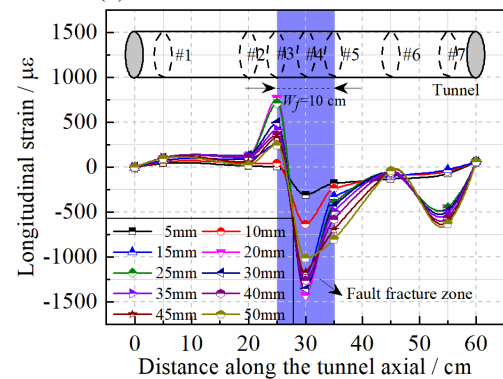
(b) Strains in the right sidewall

For the right sidewall, the liners at Section #4, #5, #6, and #7 were in a compression state, while that of Section #1, #2, and #3 were in a tension state. The maximum compression strain occurred at Section #4 while the maximum tension strain occurred at Section #3. This trend was slightly different from that of the right sidewall. By

observing the evolution of the strains with faulting distance, one can notice that the strains at Section #3 and #4 barely increased after the faulting distance reached 15 mm. This indicated that the left side wall of the tunnel began to yield after the faulting distance reached 15 mm, corresponding to a 1.5 m faulting for the prototype tunnel.

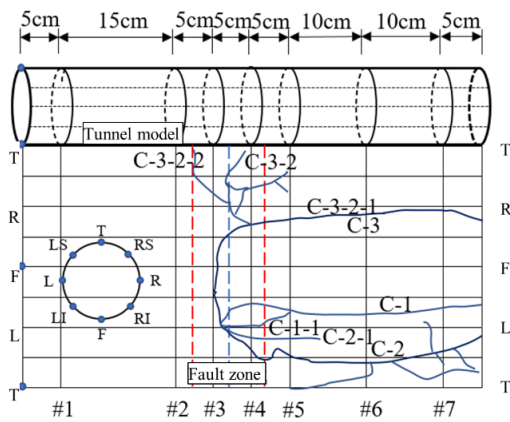
Fig. 12 Panorama view of the developed cracks

The final state of the developed cracks in the liner was plotted in Fig. 12. Circular cracks within the fault fracture zone are more significant. Longitudinal cracks are common along longitudinal tunnel especially in hanging wall, while no clear crack appeared in footwall. Or others, the tunnel damages are concentrated on fault fracture zone, and circular cracks within the fault are main crack pattern.

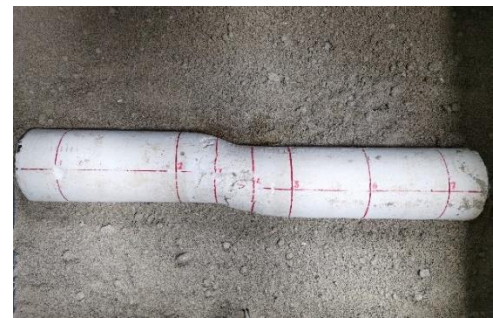
Fig. 13 The deformed tunnel model after test

The crack distribution outside of the tunnel liner might be different from that inside the tunnel liner. Clearly, the tested tunnel model (Fig. 13) exhibits a ‘S’-shaped deformation form.

The deformation in the liner was mainly focused on the fault shear zone. Multiple longitudinal and circumferential cracks can be recorded respectively. An oval-shaped deformation in tunnel sections appeared owing to the extrusion of the rock mass. In the sidewalls, notable

Fig. 19 shows the final defamation contour of the tunnel liner after 50 mm faulting. A notable S-shaped deformation profile can be logged, which was in good contrast with the test results shown in Fig. 13 at the deformation pattern of the tunnel.

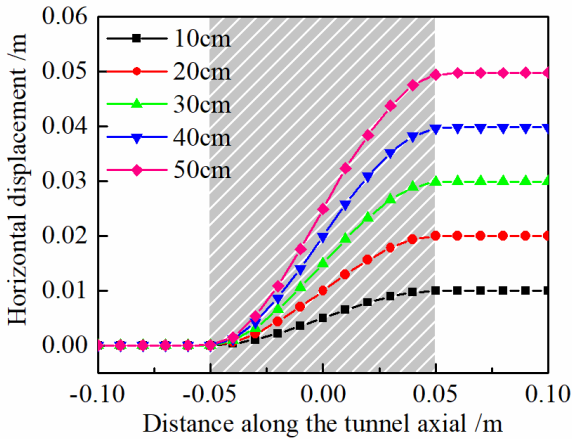
Fig. 18 The calculated horizontal displacement profile at the arch crown of tunnel

Fig. 18 shows the calculated horizontal displacement profile of the tunnel roof. The deformation of the tunnel in the fix part (foot wall) was less affected by the fault dislocation, the displacement of this part can be almost ignored. Contrastively, the displacement of the tunnel at hanging wall was almost same as the input boundary displacement. Most of the transition deformation of the tunnel liner presented at fault fracture zone, while there is no obvious at the deformation at the end of two walls.

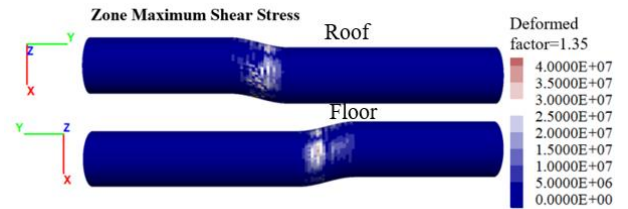
Fig. 21 Calculated maximum shear stress contour on roof and bottom of tunnel (unit in Pa)

Fig. 21 gives the calculated maximum shear stress contour on the roof and bottom of the tunnel. The maximum shear stress at the arch crown and invert of the tunnel at fault core is of significance with a peak value of 40 MPa. The distribution of the maximum shear stress at inverted arch of the tunnel is larger than one at the crown. Notable shear-induced spalling was found in the roof and bottom of the tunnel in the model test (Fig. 15). Therefore, the correctness of the current numerical modelling was verified again. This FDM model thus then can be used in further investigation of the tunnel rupture problem.
